Replacement of the BNSF Approach Spans over the Mississippi River

DAVID ROGOWSKI, P.E. AND JOSH CRAIN, Genesis Structures Inc., Kansas City, Missouri and DAN SIEVE AND KEVIN BECKER, Walsh Construction Company, Chicago, Illinois

IBC-13-32

ABSTRACT: The BNSF Railroad crosses the Mississippi River at Burlington, Iowa. The original 120-year old bridge consisted of six 250-foot approach spans, one 360-foot swing span and two 80-foot girder spans. This paper will focus on the complex planning, equipment and construction activities required to replace the approach structures in five 36-hour closures.

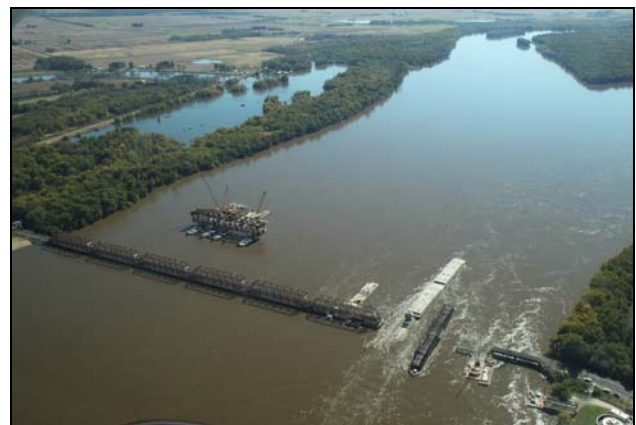
Figure 1 – Existing 120 year old bridge structure with 360-foot Swing Span

The BNSF Railroad spans the Mississippi River as part of the BNSF's Chicago to Denver corridor connecting Burlington, IA to Gulf Port, IL. The original bridge structure, constructed in 1891, consisted of six 250-foot approach span trusses, one 360-foot swing span truss and two 80-foot approach span girders (see Figure 1).

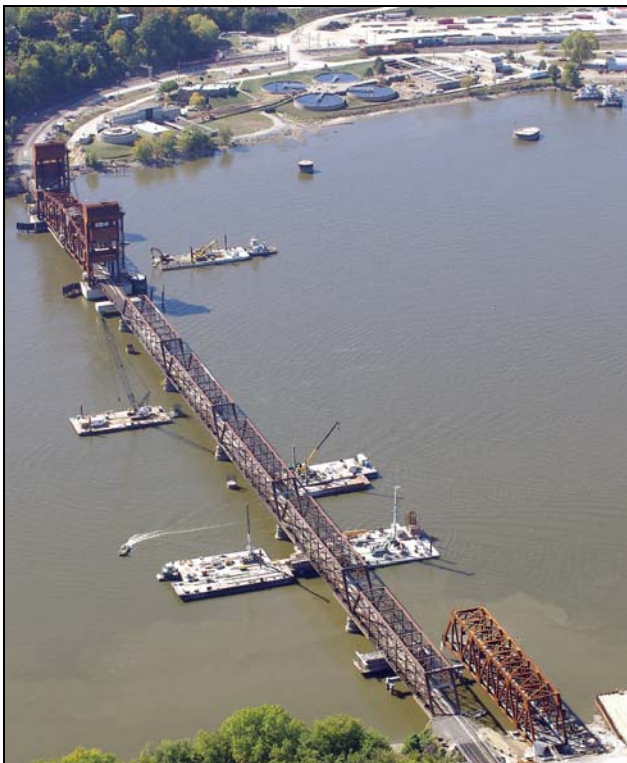
Figure 2 – Approach span truss # 1 erected at job site

The track beam system at the “Green Bay” location extended a distance over 300 feet in length (see Figure 2), allowing for multiple trusses to be stored in order to meet schedule. A similar track beam system was installed at approach span truss # 1, with a more modest total length equal to 150 ft.

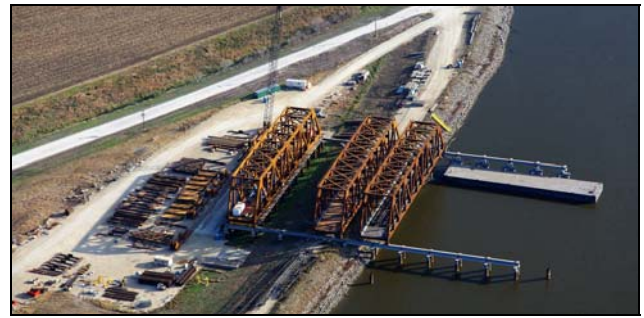
Figure 3 – Approach span trusses 2-6 erected on track system at Green Bay location

It was determined that the simplest and most efficient way to accomplish the replacement of the approach span trusses — in the four remaining 36-hour tracks closures — would be to install the new piers while the track remained in service and simultaneously erect the new 250-foot approach span trusses. In total, six approach span trusses were erected remotely from the bridge alignment while the new piers were installed. Approach span truss # 1 was erected at the job location because it spanned the existing abutment and was not accessible to any form of barge float-in installation (see Figure 2). The remaining five trusses, Spans 2-6, were erected offline at a location 13 miles downstream from the job site referred to as “Green Bay” (see Figure 3).

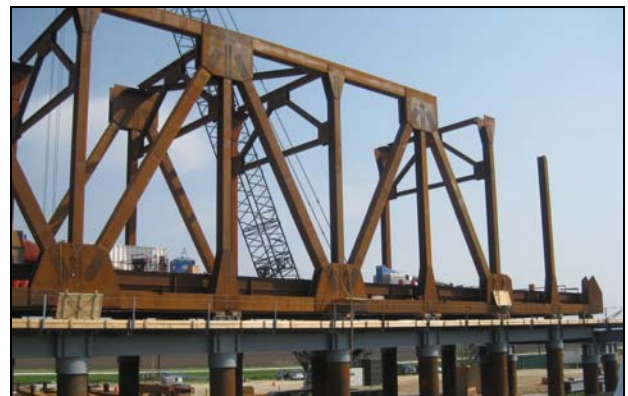
The approach span trusses, erected at the job site and at “Green Bay,” were built on similar work platform systems (see Figure 4). The work platforms were comprised of (18) 48” x3/4” support pipe piles with W33 cribbing located under each panel point (24’-6” on center). The support piles were tied together with W36x135 “struts.” The W36 “struts” also supported the work platform walkway surface comprised of W18x46’s spanning the W36 “struts” and wood planking at the deck level. The work platform minimized the need for personal fall protection while assembling the bottom chords, bottom laterals and floor system.

Figure 4 – Work platform used for truss erection

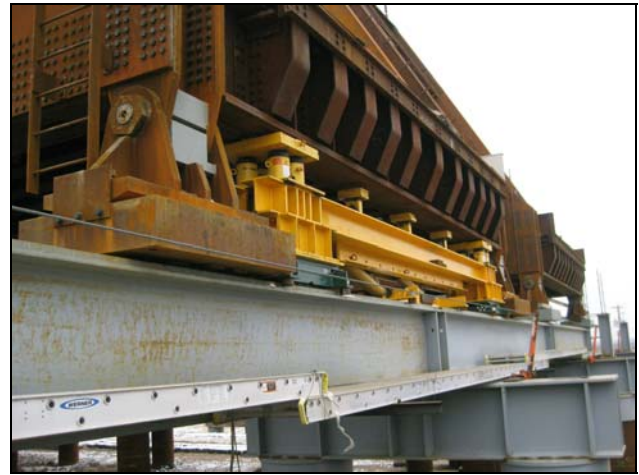
The push/pull frame supported the truss at four primary bearing locations using (4) 150-Ton hydraulic jacks at each location. The hydraulic jacks were designed to handle the truss dead load reaction of 850 kips per bearing location plus an additional 150 kips for wind overturning forces. The push/pull system was installed under strengthened jacking points on the floorbeams (see Figure 6 & Figure 7).

The horizontal movement of the truss was accomplished using (2) 100-Ton hydraulic rams with 36-inch strokes. The hydraulic rams, installed on the push/pull frame, push or pull against a stationary reaction sled pinned down to the track beams. As the rams pushed or pulled the reaction sled, the truss and push/pull frame would move along the top of the track beams by rolling on Hillman rollers [(2) 300-Ton rollers provided per bearing location]. The reaction sled delivered the

Figure 6 – Push/Pull frame and reaction sled used for horizontal sliding of trusses shown at “Green Bay” location

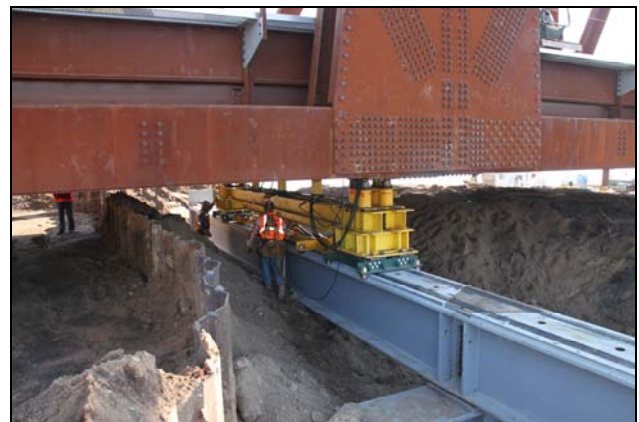
Figure 7 – Push/Pull frame and reaction sled shown at approach span truss # 1

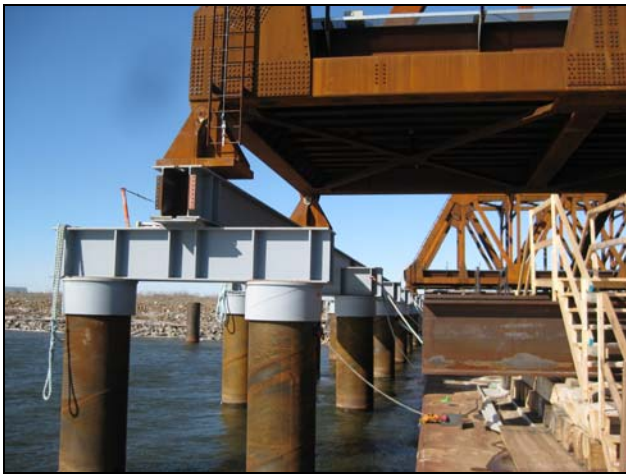
The track beam system was designed to handle the full 1000 kip roller reaction of the push/pull frame and reaction sled. The track beams consisted of (2) W36x302's with 2"x 32" cover plates top and bottom. The track beams spanned between 2-pile bents (see Figure 8) consisting of (2) W36x260 cap beams and (2) 48"x3/4" pipe pile driven at 1000 kip capacity.

Figure 8 – Typical track beam system pile bent

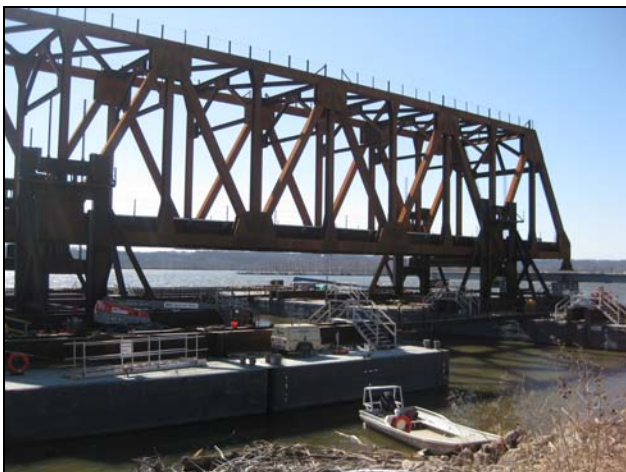
Once the approach span trusses had been erected at the “Green Bay” location and the completed trusses had been rolled or slid into position over the (4) 195-foot by 35-foot by 10-foot deep float-in barges, the trusses were lifted off the track beam system onto the barges with the use of jacking towers. The jacking towers were designed to support the full 3400 kip weight of the new approach span trusses (see Figure 9). The barge draft generated by the weight of the approach span truss was approximately 2’-6”.

Figure 9 – Approach span truss loaded onto float-in barge jacking towers

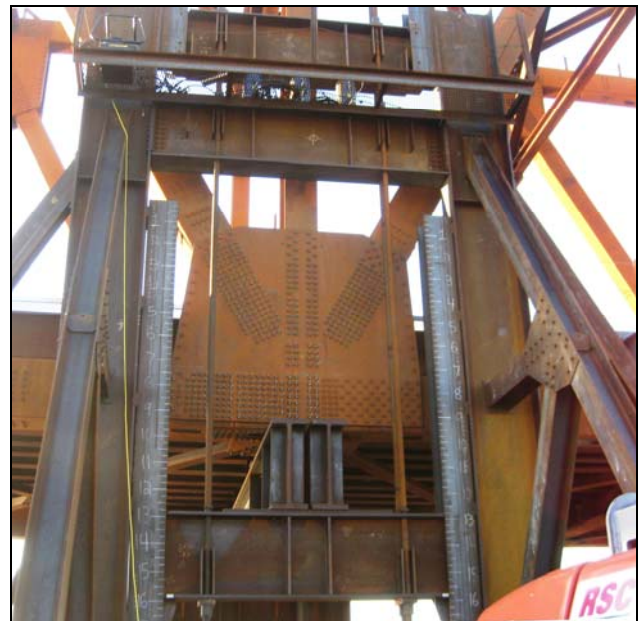
The jacking towers used for float-in (comprised of heavy W36’s framing) were used to support (2) W36x302 “lifting beams” in direct contact with the lifted truss (see Figure 10 and Figure 11). The “lifting beams” spanning between the towers were supported at each end by (4) 2-1/4” Gr. 150 threaded rod which could raise the truss through a range of approximately 20 feet.

Figure 11 – Side view of jacking tower and “lifting beam” used for truss float-in

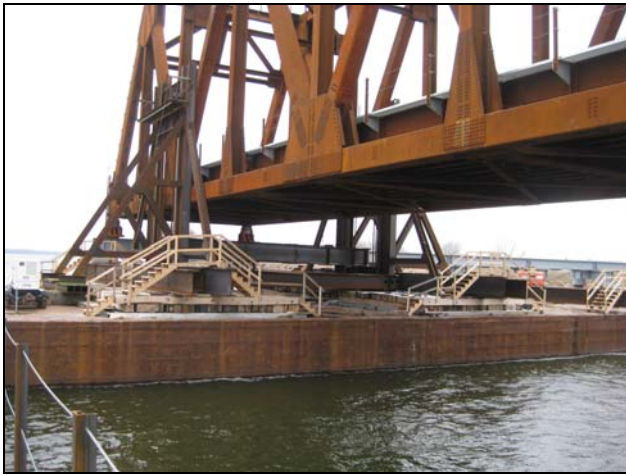
The support of the jacking towers (for all but one barge pair) was provided by a spine beam system that also linked together the dual 35-foot by 195-foot by 10-foot barges. The spine beams consisted of double W36x300's and W40x431's straddling the barge deck and secured to the barges with reinforcing plates welded to the sides of the barges. The one exception to the float-in tower being supported on the spine beams arose because after field testing, two barges were determined to have only a minimal wall thickness of 5/16". The load for this barge pair had to therefore be distributed to a larger area on the barge deck using sandboxes (see Figure 12). Where possible, the sandbox detail is a more effective and preferable detail to get the load to the barge deck. However, this is only the case if the barges are loaded symmetrically. For this particular project, the sand box detail would not work to support each tower configuration because of the unsymmetrical tower placement on the barges required to accommodate interference issues with the existing and new piers.

Figure 12 – Sandboxes support method on barges

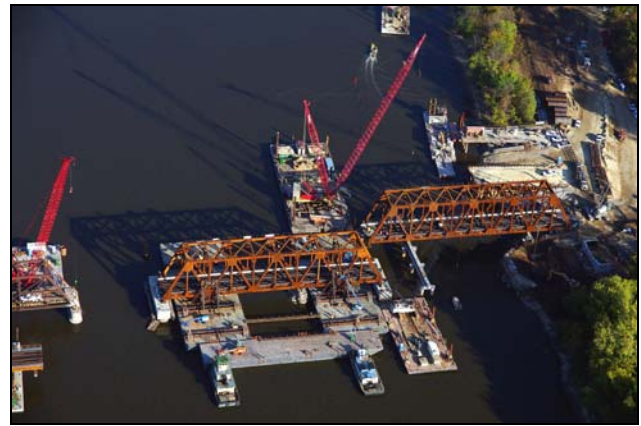
The final challenge faced with the float-in installation of the approach span trusses was positioning the dual 35-foot by 195-foot linked barges into final alignment without the use of spuds. The alignment method used, after the tugs positioned the barges within 2-3 feet of the final bridge alignment, was to use come-a-longs to fine tune the final position of the truss (see Figure 13 & Figure 14).

Figure 13 – Tugs positioning truss near final bridge alignment

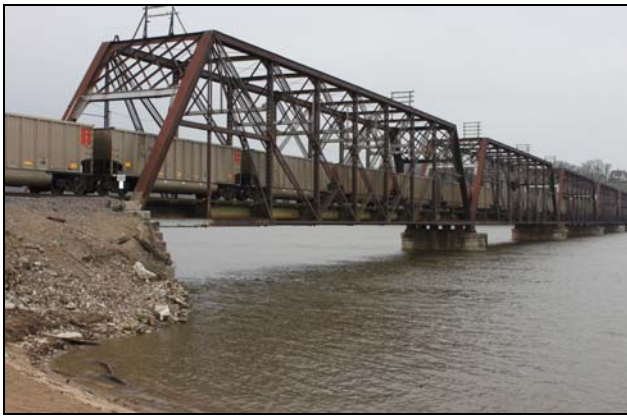
Each of the five 250-foot existing approach span trusses were floated out during track closures in sequence with the new approach span truss float-ins. The existing approach span trusses were efficient Morrison trusses with true tension members installed where tension members were needed (see Figure 15). That design philosophy presented a problem when attempting to pick the truss at panel point L1 where there was no compression capacity in the vertical hanger (Figure 16).

Figure 15 – Existing approach span truss

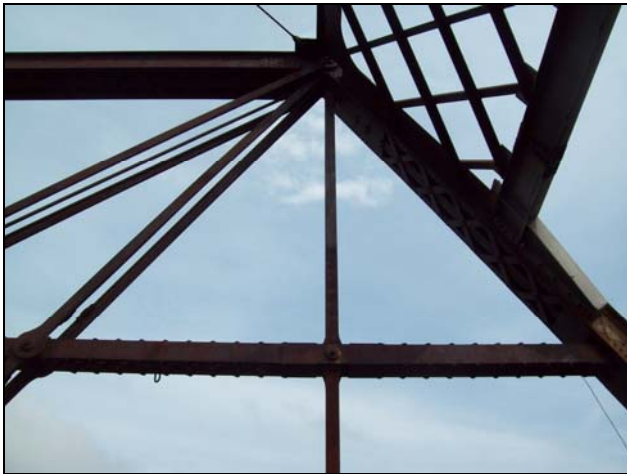
Figure 16 – Vertical hanger at panel point 1

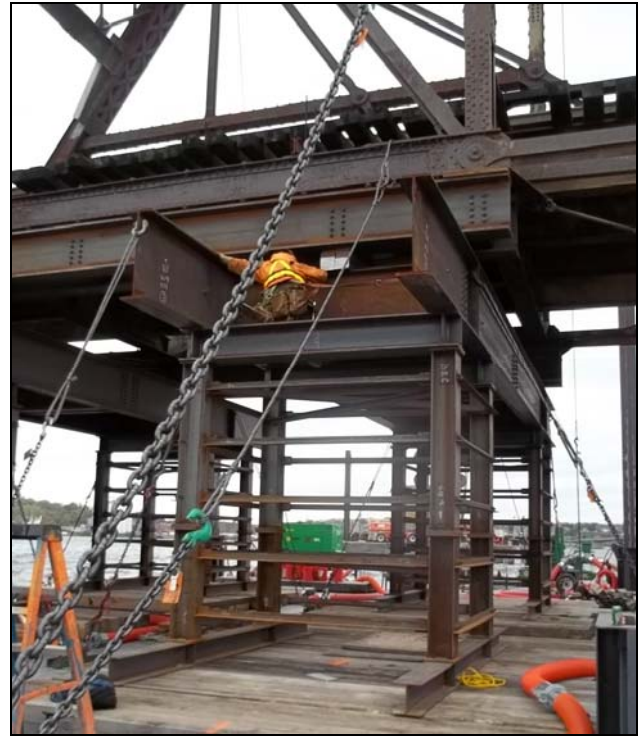
The solution was to span to panel points L0 and L2 using the existing bottom chord in combination with a newly installed W24 underslung beam (see Figure 17).

Figure 17 – Bottom chord and W24 underslung beam used to deliver load around vertical hanger designed for tension

The float out barge towers had to be able to be adjusted plus or minus 1-foot within one day's notice (see Figure 17). Two to three days prior to each float-out the barge towers were built to heights that would accommodate the anticipated river gage. A day prior to track closures, the barges were aligned with the existing bottom chord and the newly installed underslung beam (see Figure 18). The barge was secured to the existing bridge and was held at that position until the beginning of

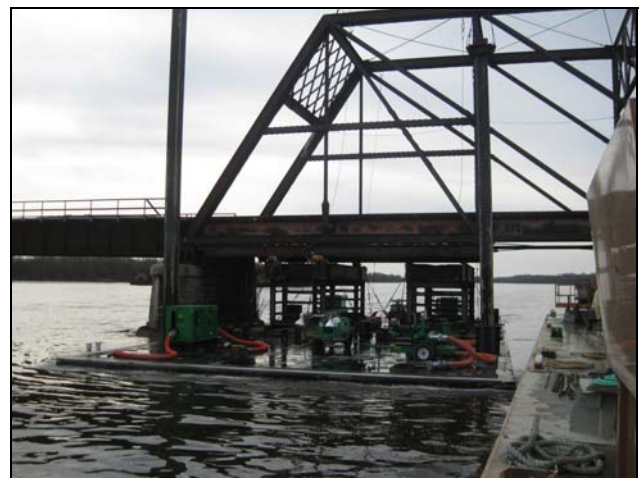
Figure 18 – Barge aligned with existing truss in preparation for track closure

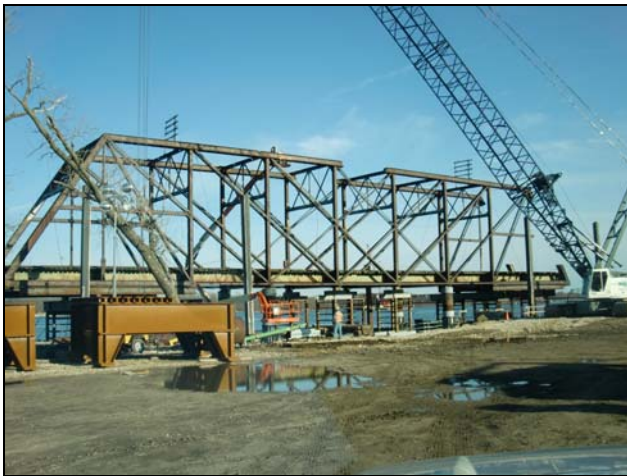
Once the existing approach span trusses were moved offline, they were taken across the river to be demolished and scrapped. The demolition took place on barges, and while the existing truss removal was achieved with two 55-foot by 120-foot barges, the demolition required a third barge be installed in order to control the relief of stresses as the truss was being deconstructed (see Figure 20 & Figure 21).

Figure 20 – Existing approach span truss with portion of top chord and diagonal removed

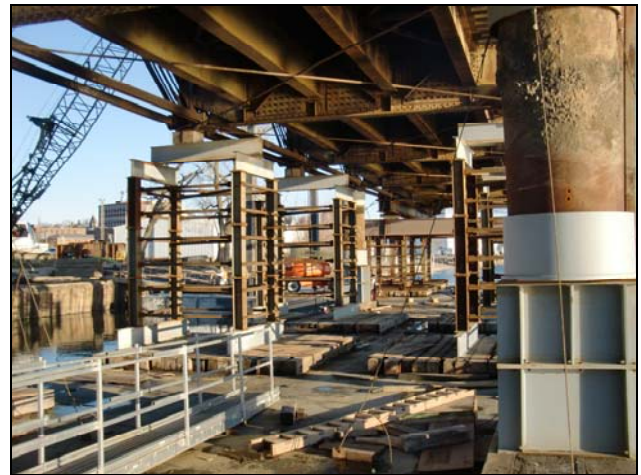
Figure 21 – View of third barge and additional tower support provided during demolition
