# Construction of the Broadway Bridge Arch Spans over the Arkansas River

STEVE EADS, P.E., AND JOHN BOSCHERT, P.E., S.E., Genesis Structures Inc., Kansas City, MO and COOPER KYHL AND KYLE ALLEN, Massman Construction Co., Kansas City, MO

IBC-17-31

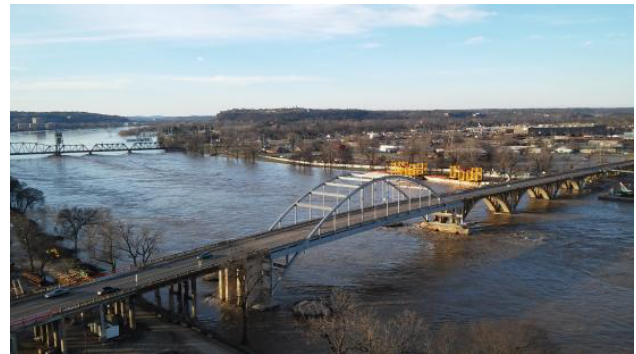
Figure 1 - Original Bridge

The original Broadway Bridge was constructed in the 1920s and consisted of several cast-in-place concrete spans highlighted by five 200' concrete spandrel arch spans over the river. The original bridge was modified in 1974. A single 412' steel through arch span replaced two of the original concrete spandrel arch spans. The original bridge prior to replacement can be seen in Figure 1.

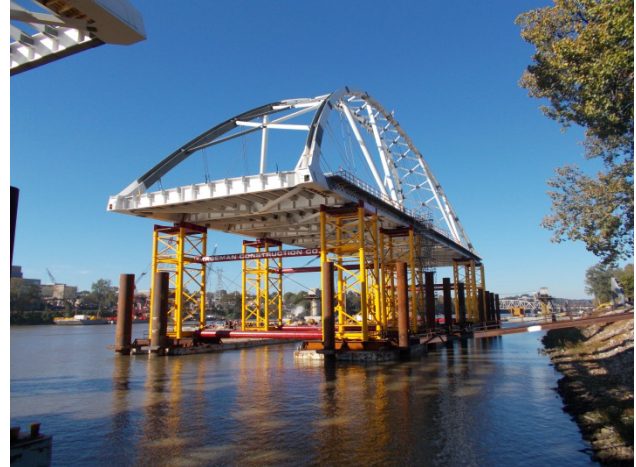
Figure 2 - Accelerated Bridge Construction

Various techniques for construction of the arch spans "off-line", and moved into position were evaluated. By constructing the arch spans "off-line", they could be partially complete prior to closing the existing bridge and beginning the 180 day closure window. The selected method was to erect the tied arch spans on steel falsework towers high above the river (at the approximate final elevation) supported on barges as seen in Figure 2.

Following fast track demolition of the existing bridge, the tied arch spans were floated into position and supported on the newly constructed bents. After a successful float in, concrete deck placement and other final construction activities could take place.

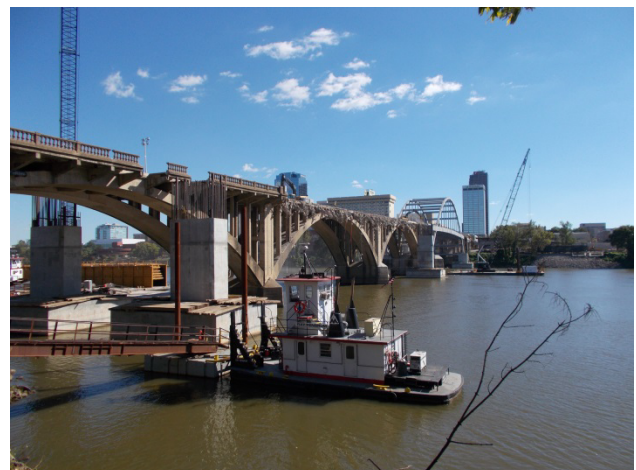
Figure 3 - New Bent Construction

The new bridge is located along a very nearly identical horizontal alignment with the existing bridge. Thus the existing bridge had to be demolished prior to construction of the new bridge, with a few exceptions. Prior to demolishing the existing bridge the new substructure could be partially constructed. The substructure layout for the tied arch spans were such that they did not interfere with the existing bridge substructure layout, so the new bents could be constructed up to an elevation that did not interfere with the existing bridge superstructure or demolition activities. An example of this can be seen in Figure 3.

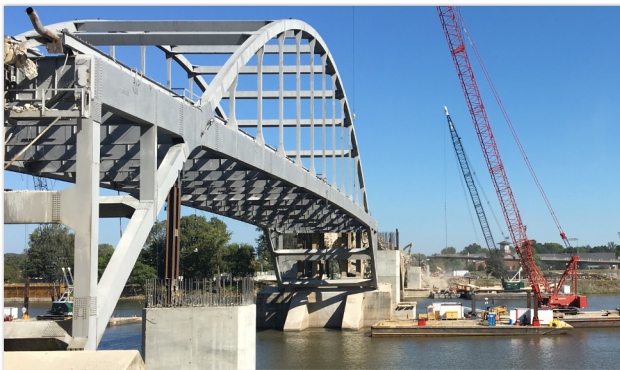
Figure 4 - New Bent Protection

After consideration of many alternatives, the decision was made to support the existing structural steel that was to remain intact following the explosive demolition with the new bent itself. A steel post was cast into the new bent and connected directly to the existing arch rib (just below the knuckle intersection with the girder). This can be seen in Figure 4. Note that it was not connected to the arch rib until after the existing bridge was no longer in service and just prior to the explosive blast.

The explosive demolition caused a dynamic response of the remaining structure, as the supported load was instantly removed. The forces imparted during this dynamic response were analyzed and all structural components were evaluated. The steel arch span was successfully removed without any significant damage to the newly constructed substructure.

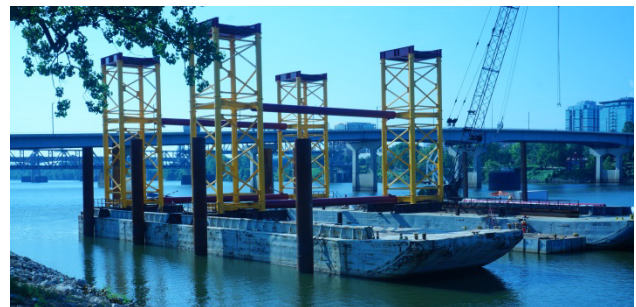
Figure 5 - Barge & Falsework Layout

The location of the supporting towers on the barges was determined based on the span float-in geometry conditions and the steel erection sequence. The towers were located directly under the first superstructure field segment to be erected for stability and temporary support conditions during assembly. The position and geometry of the new piers and footings limited the position of the barges relative to the new spans for the float-in condition as the barges had to clear the new footings during the span installation. These geometry conditions resulted in the towers being located near to the stern-end of the barges, resulting in eccentric load effects on the barges. Sequential ballasting was used to maintain vertical geometry of the arch structure during assembly. The barge and falsework tower layout can be seen in Figure 5.

The construction plan developed in the project planning phase was to assemble the structural steel arch spans on towers supported by the barges so that the float-in operation would deliver the spans directly onto the permanent bearings without any vertical lifting. As such, custom designed and fabricated towers were utilized to support the steel arch spans on the barges. The height of the towers (and associated height of steel erection above the barges) varied between approximately 56'-68'.

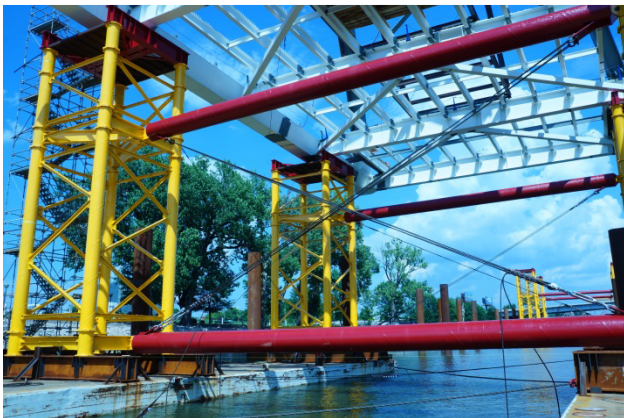
Figure 7 - Falsework Grillage & Bracing System

The top of the towers included a conventional grillage system that directly supported the underside of the tie girders and consisted of W36 beam members. The base of the towers was supported on a lower grillage system that also consisted of W36 members and delivered load to the barge at the outer edges and at the center bulkhead. The upper and lower grillage systems can be seen in Figure 7.

The struts between the parallel barge towers were 36" diameter steel pipes, and diagonal bracing was wire rope. The tower bracing can be seen in Figure 7. These elements were sized to develop strength and stiffness required to develop the composite catamaran barge system, subject to appropriate load effects anticipated during construction.

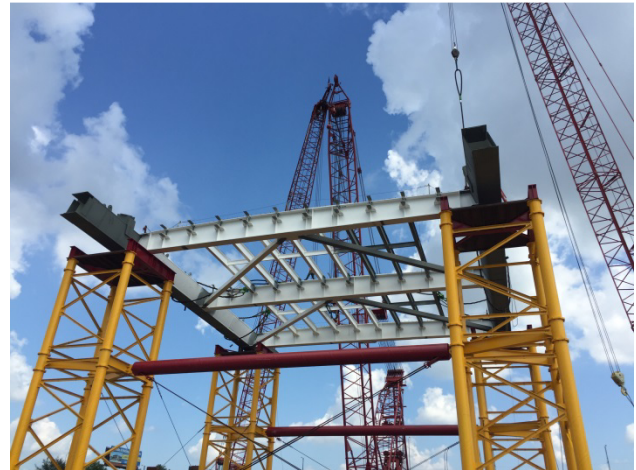
Figure 9 - Sequence 1

CONSTRUCTION SEQUENCE NO. 1 - The floor-system located between field splices TS1 & TS3 was installed. The tie girders and associated floorbeams and stringers were assembled on the ground and

lifted into position on top of the falsework. This can be seen in Figure 9. This was termed the “mega lift”, as it was the heaviest lift for the project weighing in at approximately 625,000 pounds. The lifting and rigging evaluation required to perform this operation (and other lifting operations to follow) will be discussed in a following section.

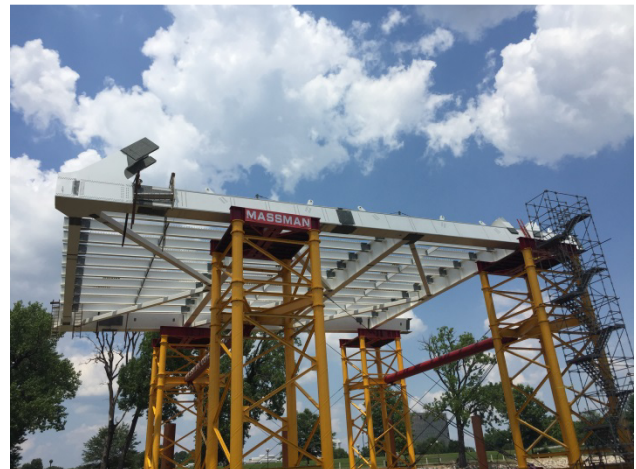
Figure 10 - Sequence 2

CONSTRUCTION SEQUENCE NO. 2 - The knuckle (intersection of arch and tie girder) and associated floorbeams and stringers were installed. This can be seen in Figure 10. It is clear the structural adequacy of the tie girder must be considered for the large cantilevered portion of the floor-system beyond the falsework support. As noted previously all construction stages were evaluated for adequacy.

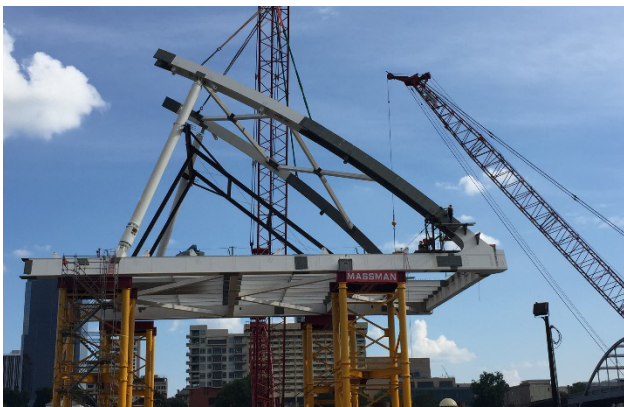
Figure 11 - Sequence 3

CONSTRUCTION SEQUENCE NO. 3 - The arch members located between field splices RS1 & RS3 were installed. The arch segments and associated

lateral bracing members are being positioned as seen in Figure 11. The extreme cantilevered condition of the arch necessitated additional support to reduce the bending demands to within the allowable limit. The use of an arch support strut was required and will be further discussed in construction sequence 4.

To hold the arch support struts in the proper position to receive the arch segment, a strut erection frame was used. This strut erection frame can be seen in Figure 11 to Figure 16 This was required to hold the strut in the proper alignment prior to connection with the arch member.

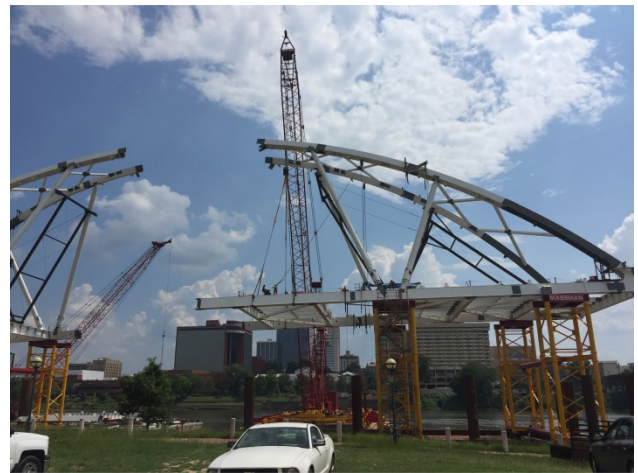
Figure 13 - Sequence 5

CONSTRUCTION SEQUENCE NO. 5 - The adjoining floor-system members between field splices TS3 & TS4 were installed. The tie girder and associated floorbeam and stringer members are being positioned as seen in Figure 13.

Without additional support, the tie girder demand, due to the extreme cantilevered condition of the floor-system, would have exceeded capacity. In order to avoid this condition, a temporary cable was connected from the arch (between struts) to the

cantilevered end of the tie girder to support the floor-system beyond the falsework (installed prior to release from crane support).

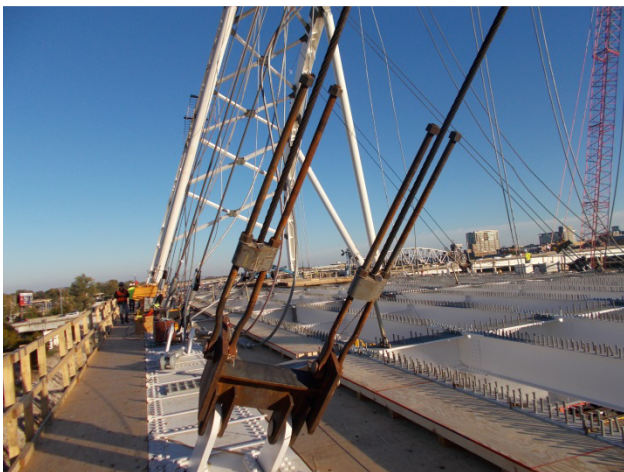
Figure 14 – Temporary Hanger Bracket & Adjustable Lower Socket

It was desired to use the existing pin connection plates on the arch and tie girder (for the permanent cables) to provide attachment of the temporary cable that was to provide the required support of the floor-system. With the use of the permanent pin connection plates the cable would interfere with the arch support strut. To avoid interference with the strut and still make use of the existing pin plates, a custom bracket was fabricated as seen in Figure 14. The temporary cables can also be seen in Figure 15.

A 1¾" diameter XIP wire rope with an open bridge socket was selected and can be seen in Figure 14. This socket type is more easily adjustable than the permanent cable sockets (to be discussed in a following section). The temporary hanger and bracket were designed for the extreme loading condition experienced during construction.

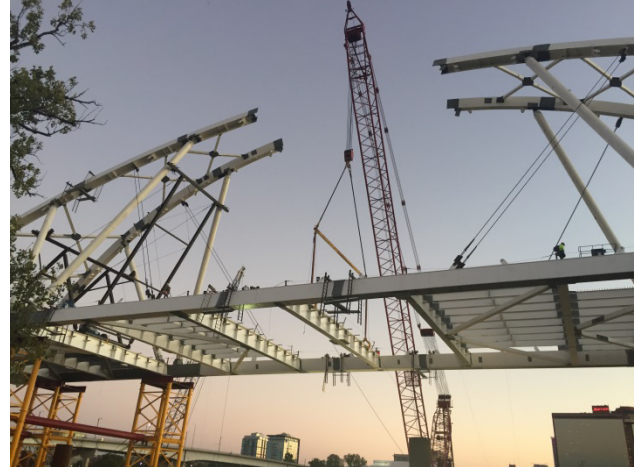
Figure 15 - Sequence 6

CONSTRUCTION SEQUENCE NO. 6 - The floor-system closure segment between field splices TS4 & TS5 was installed. This can be seen in Figure 15. At this time, the two barges supporting each half of the arch were no longer fully independent.

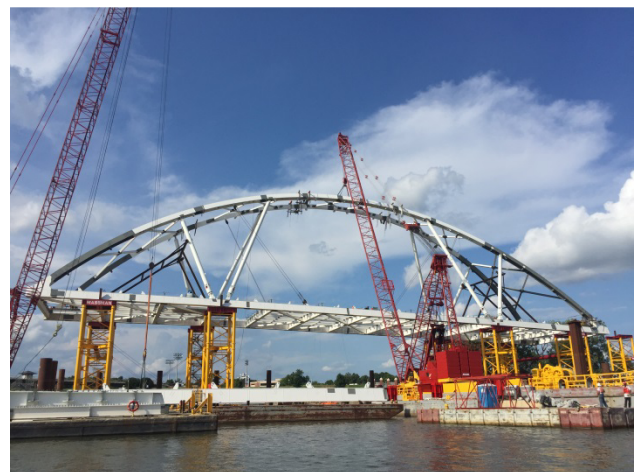
Figure 16 - Sequence 7

CONSTRUCTION SEQUENCE NO. 7 - The arch closure segments between field splices RS5 & RS8 were installed. For the first time, the arch began to behave like an arch. There is now axial compression in addition to the bending stresses that have controlled the design until this stage. This condition can be seen in Figure 16.

As each corner of the arch is supported by a unique barge (four total per span) it is effectively supported by a variable platform. The elevation of the arch at the four field splices (RS5 & RS8), awaiting the arch closure segment, could potentially be at slightly different elevations. As the arch closure segment was installed it was necessary to have the ability to alter the position of the previously installed segments. To achieve this adjustability, the arch support strut was designed to be telescopic. The necessity for the arch support strut to be telescopic will be further discussed in a section to follow.

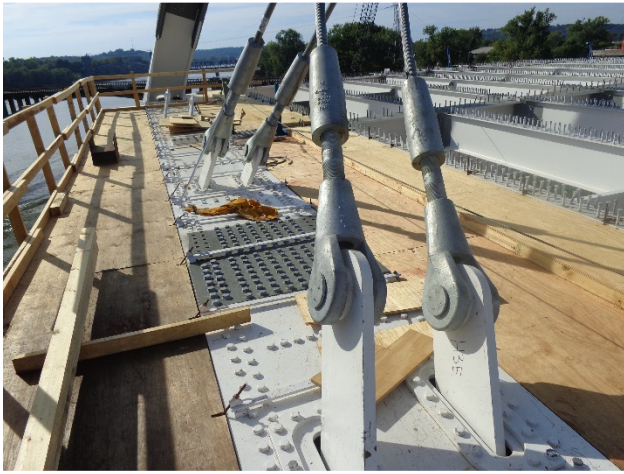
Figure 17 - Lower Hanger Socket

Permanent Hangers - There are two 2 3/8" diameter A586 strands at each permanent hanger location. There are 22 permanent hanger locations on each side of the arch (44 total), therefore a total of 88 cables are required per arch. Each cable is pin connected to the arch with an open prolite socket and pin connected to the tie girder with an

adjustable prolite socket. The lower socket provides approximately +/- 6" of length adjustability and can be seen in Figure 17.

A detailed length calculation was required for each hanger. The anticipated final deflections from the staged erection analysis were superimposed with the fabricated cambered geometry of the structural steel (as defined in the original bid documents) to define the stressed hanger length. To define the hanger cut length, the associated final hanger force was also specified. The hanger length was cut to target a 10" gap in the lower adjustable socket to provide the maximum amount of adjustability in either direction.

To increase the tension in the hanger the length of the hanger is reduced by bringing the two halves of the lower adjustable socket together. This gap dimension is adjusted by turning a threaded rod further into the lower socket body. The threaded rod is reverse threaded so that it penetrates into each of half of the lower socket as it is turned.

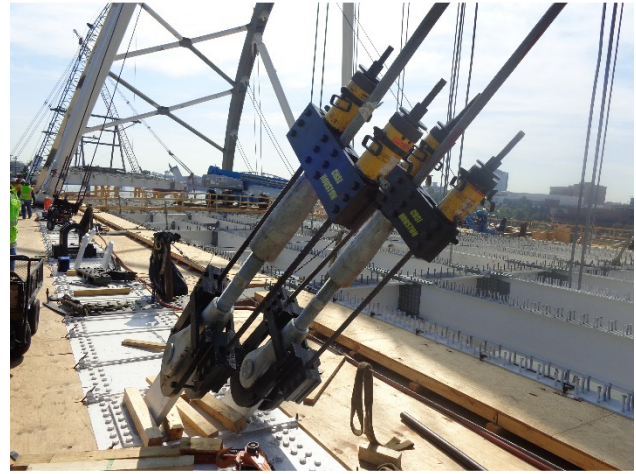
Figure 18 - Tension Bracket

As the tension in the hanger increases, so does the tension in the threaded rod. The ability to turn the threaded rod (to adjust the hanger force) under load is not possible, therefore the load in the threaded rods must be practically eliminated when turning the rod. A tension bracket was designed to unload the threaded rod as seen in Figure 18.

The tension bracket used four 60ton center hole jacks to transfer the hanger force directly from the upper to the lower half of the adjustable socket. In this manner, all load bypasses the tension rod and allowed the rod to be turned. This results in alteration

of the length and therefore tension in the hanger. The tension bracket was required for the installation of all hangers.

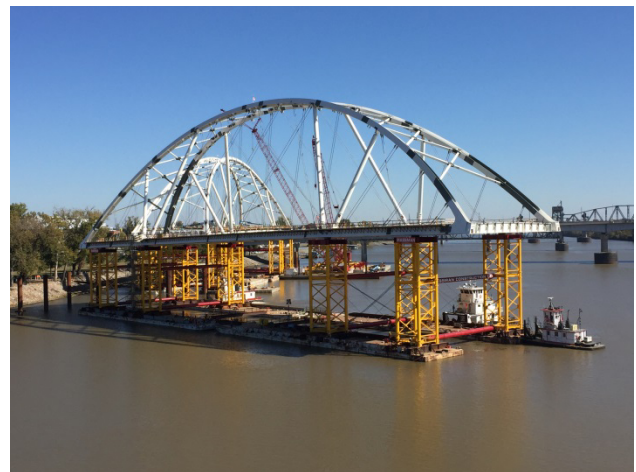
Figure 19 - Sequence 10

CONSTRUCTION SEQUENCE NO. 10 - The arch spans were floated into position. The arch is transferred from the falsework (on barges) to the permanent bearings on the newly constructed bents. The first arch span during transport can be seen in Figure 19.

Weighing in at more than 4,000,000 pounds and with a center-of-gravity nearly 100' above the river, the transportation of the assembled arch to its final resting place was a delicate operation. Any sudden acceleration or deceleration of the barge support system (such as by barge impact with an underwater obstruction) would have resulted in a large inertia load to be resisted by the cable bracing between falsework towers. For design, this impact loading effect was assumed to be 10% of the weight of the arch to act in any the orthogonal directions.

Traveling less than 1200 feet to the final position, a series of winch lines were installed to assist multiple tug boats to pull/push each arch into position. With the use of both the winch lines and tug boats the barge supported arch was slowly maneuvered into position without incident.

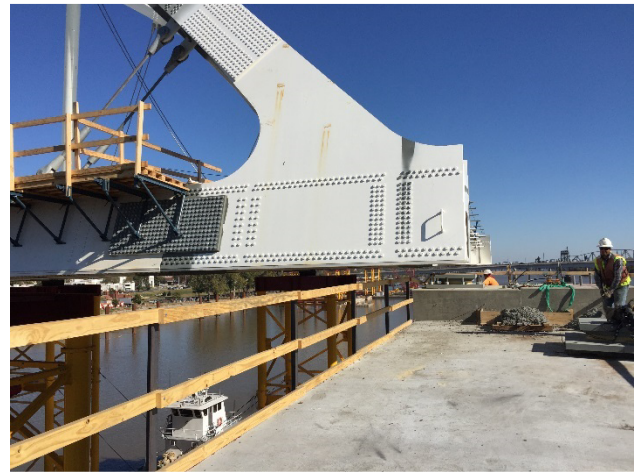
Figure 20 - Knuckle Clearance above Bearing

As the bridge was floated into position the elevation of the knuckle had to clear the bearings atop the newly constructed bents. Specifically, a target clearance of 6" to 12" was selected. Without clearance above the bearings the bridge would not have been able to float into position, but too much clearance could also prove problematic as well.

It was estimated that under the full weight of the tied arch span, falsework towers, and temporary work platforms, the barges would have approximately 2.5' of freeboard remaining. Once situated hovering directly above the permanent bearings the bridge had to be lowered into position. To set the bridge down, a ballasting plan was defined to lower the barges by flooding specific tanks in the barge. It was estimated that once the initial touch-down occurred the barge would be required to drop an additional 6". This accounted for structural displacement of the arch at the falsework location and providing clearance between the top of the falsework and bottom of the tie girder once the transfer has occurred. With 12" of clearance and 6" of structural displacement, it was estimated that the barge would require a ballasting plan to drop 18". Starting with 2.5' of freeboard, there would only be 1.0' of freeboard remaining. Thus, a maximum target clearance was selected to ensure there would be remaining freeboard following the successful transfer of arch support from the falsework to the permanent bearings. The knuckle clearance above the permanent bearing during float-in operations can be seen in Figure 20.

To define the falsework height, many factors had to be considered to assure the desired clearance was achieved. This included considerations such as the river elevation anticipated during float-in, the expected barge freeboard while under the full weight of the supported load, barge ballasting requirements to maintain level conditions, the tip deflection at the cantilevered knuckle, and the unique pedestal elevations at each bent.

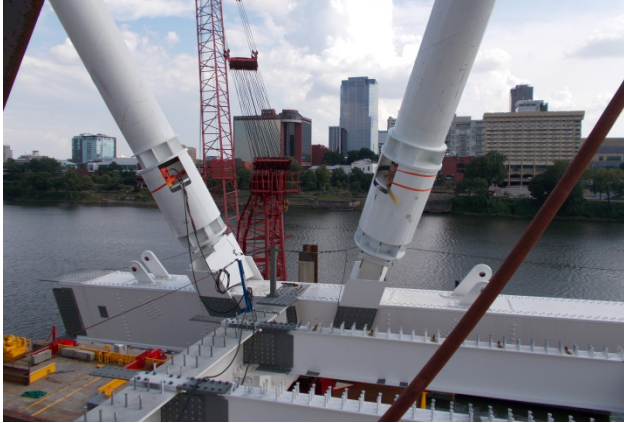
Figure 21 – Telescopic Strut

CONSTRUCTION SEQUENCE NO. 12 - The arch was no longer being supported on falsework, therefore the struts are no longer required. In addition to geometric control, as discussed in construction sequence 7, the telescopic abilities allowed for easy loading or unloading of the strut as required during construction. To unload the struts the two 200 ton jacks, located within the telescopic end of each strut, were simply engaged and shim plates were

removed. This allowed the struts to be unloaded in a controlled manor without risk to personnel performing the field operations. The telescopic end of the strut with window opening for jack access can be seen in Figure 21.
