# Demolition of the Broadway Bridge over the Arkansas River

Ben Pendergrass, Ph.D., P.E. and John Boschert, P.E., S.E., Genesis Structures, Inc., Kansas City, MO

IBC 18-83

ABSTRACT: This paper details the demolition of the 93-year-old Broadway Bridge over the Arkansas River. The bridge comprised 37 concrete-girder spans, three concrete-arch spans, and a single steel-arch span. Demolition activities occurred simultaneously with new construction over a short duration, requiring multiple machines to operate on the bridge at once for deck and girder removal. Spread-footing pier-stability limitations dictated that explosive demolition be selected as the demolition method.

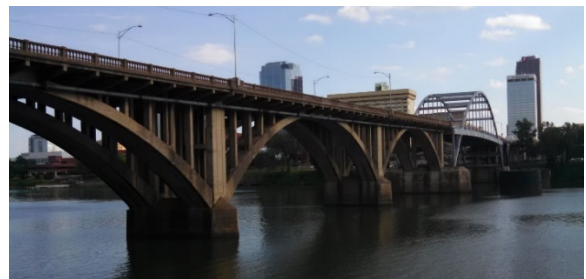
Figure 1 – Concrete Arches

The Broadway Bridge has been a primary route over the Arkansas River for nearly a century, carrying traffic between downtown Little Rock and North Little Rock, Arkansas. Constructed in 1923, the bridge originally comprised of 37 cast-in-place concrete girder spans and five 200-ft concrete arch spans. In 1974, two of the concrete arch spans were replaced with a single 412-ft steel arch span. The entire length of bridge was successfully demolished in 2016 and replaced with two 440-ft tied-arch spans which were constructed on barge-supported falsework near the shoreline and then floated into position.

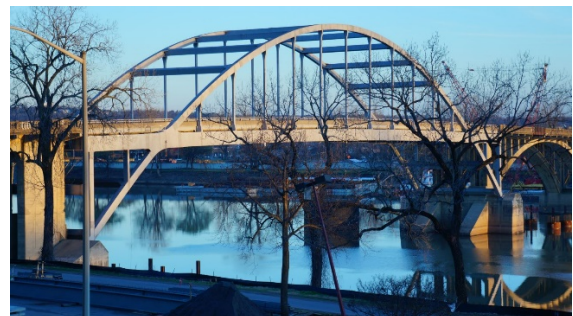
Figure 2 – Steel Arch

The deck of the steel arch span was much newer than the concrete spans and had greater material strength. The stringers and floorbeams supporting the deck were determined to have adequate strength to support the demolition operations.

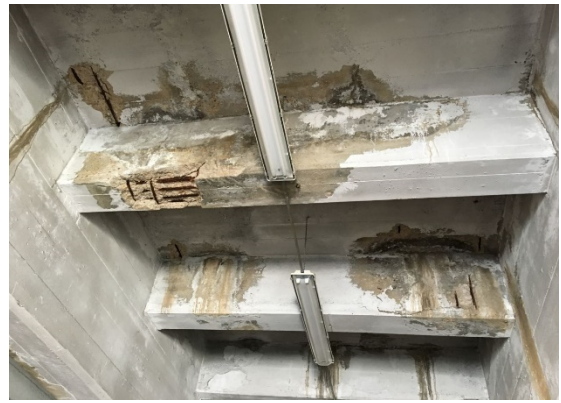
Figure 4 – Exposed Reinforcement in Beam

A full evaluation of the structure was completed to determine what method and sequence of demolition would be feasible. The concrete arch and approach spans were nearly 100-years old by the time of demolition and were in a deteriorated condition. Much of the deck was in poor condition, with significant spalling observed from underneath at many locations.

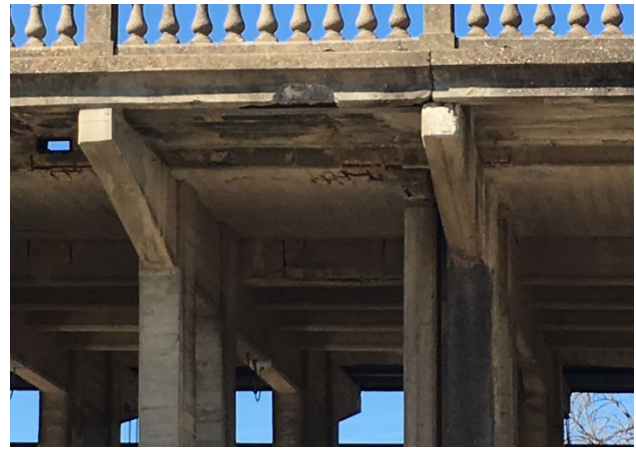
Figure 6 – As-Built Spandrel Columns

During a site visit, a number of discrepancies were observed between the original construction documents and the as-built condition of the bridge. At a few locations near expansion joints, two narrow spandrel columns were constructed instead of the single, wider column shown in the plans. These narrower columns were found to have a lower axial capacity due to their slenderness. At other locations, large holes were found cut through the center of capbeams for utility access. After these observations, a thorough investigation of the constructed-condition of the structure was conducted to confirm the accuracy of the demolition analysis.

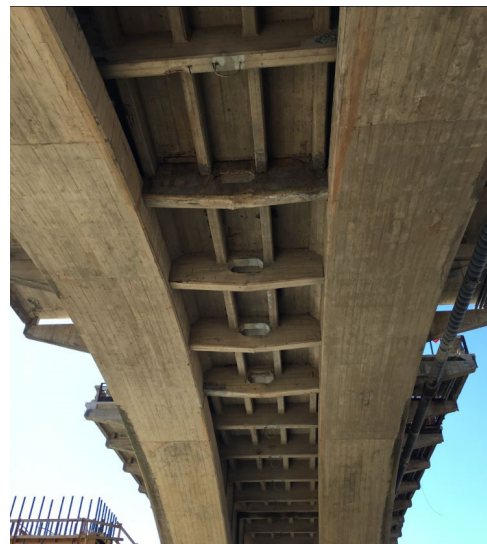
Figure 7 – Large Holes in Capbeams

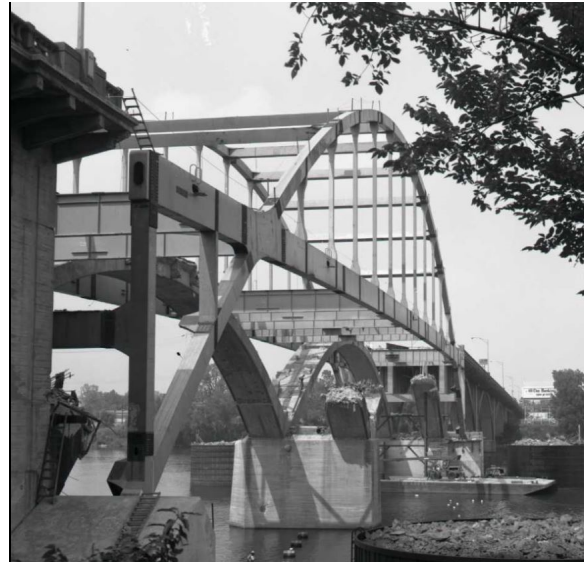
Figure 8 – Previous Demolition (1974)

For this preliminary demolition plan to be feasible, the arches were required to support their own self-weight in flexure after being cut. While an arch is intact, it primarily experiences axial compression with little flexure. After a section is cut, however, the arch no longer experiences axial load and begins to act as a beam with significant flexure. During an evaluation of the flexural capacity of the arches, photos from the steel arch construction from the 1970s were investigated. In the photos, it was discovered that falsework was required to support the cut concrete arch only a short distance from the pier, suggesting the cut arch was unable to span a great distance while supporting self-weight.

The evaluation of the flexural capacity of the arches ultimately determined them to be inadequate to support their own self-weight, eliminating the option of cutting the arch during demolition. The conclusion was correspondent with the photos of previous demolition. At this time, explosive demolition was considered as the most viable option.

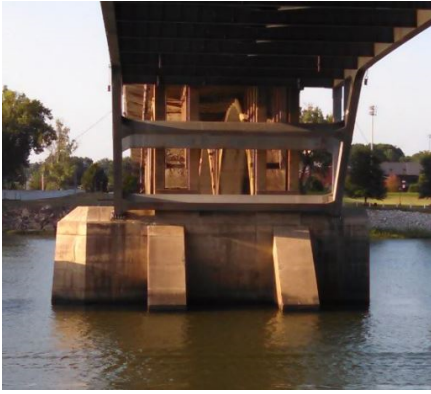
Figure 9 – Counterweight Added to Pier 2

The method of construction used for the steel arch replacement (1974) was important in fully understanding loading scenarios which the piers had previously experienced. During the replacement of two of the concrete arch spans, additional concrete was added to the outer arch pier (Pier 2) to act as a counterweight.

This counterweight provided stability to the pier against overturning as the concrete arches were removed from one side. The need for this counterweight suggested that the remaining unmodified piers could not support load from the concrete arches on only one side.

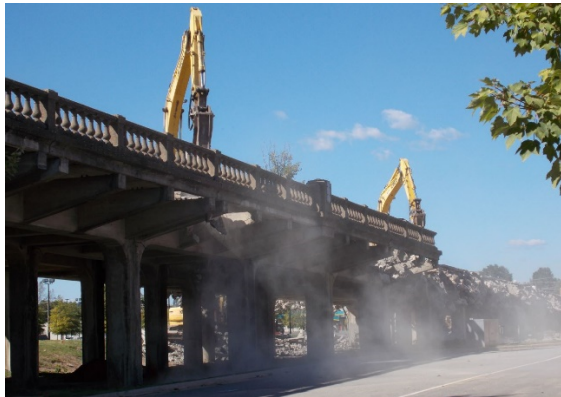
Figure 12 – Multiple Excavators on Deck

Demolition activities began with removal of the deck in each zone. Multiple excavators utilized impact hammers to break up the concrete, which then fell below.

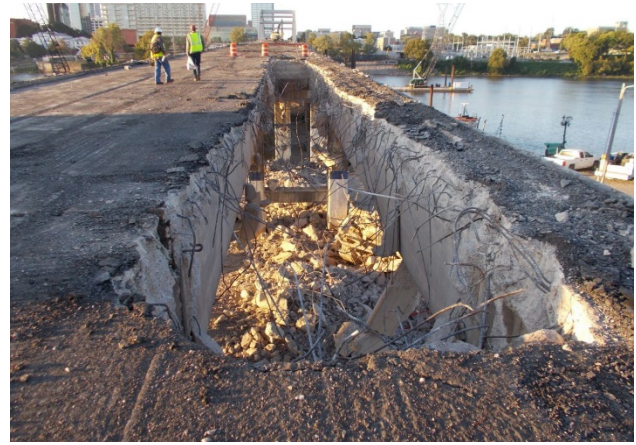
Figure 13 – Deck Removed Between Girders

For the approach spans, the excavators operated directly over longitudinal girders and chipped away the concrete between. After the girders were all that remained, a high-reach excavator knocked them to the ground.

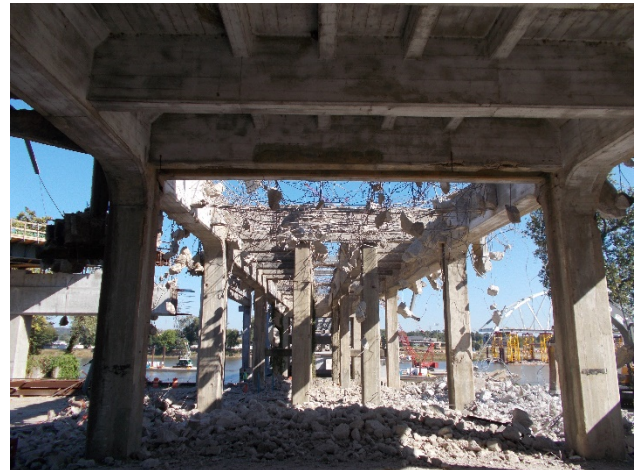
Figure 14 – Deck Removed in Approach Spans

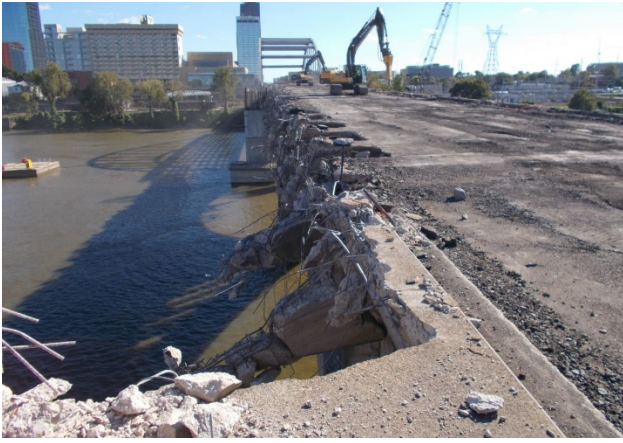
Figure 15 – Deck Overhang Removed

Beginning on the south concrete arch span, the excavators first removed the outer 7-ft of deck overhang and crossbeams. After the overhang removal had progressed 200-ft, an additional excavator followed behind and removed the remaining portion of the deck, crossbeams, and spandrel columns. To reach the lower portions of the spandrel columns, it was necessary for the excavator to be positioned very close to the demolished edge of the deck – approximately 1-ft from the edge at times. Restrictions were placed on excavator positioning near expansion joints in the spans to prevent the machine from being supported on isolated sections of deck.

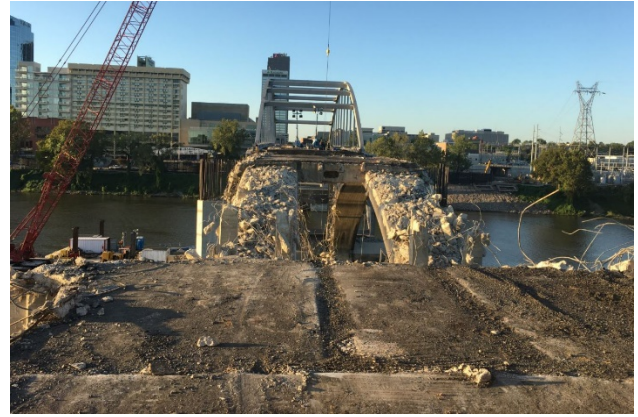
Figure 18 – Edge of Deck Removal

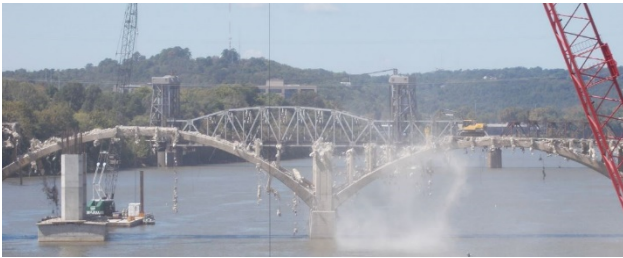
Figure 16 – Excavator Deck Removal

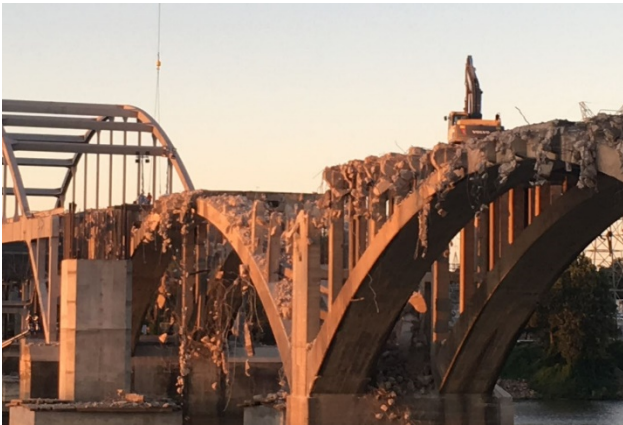
Figure 17 – Excavator Deck Removal

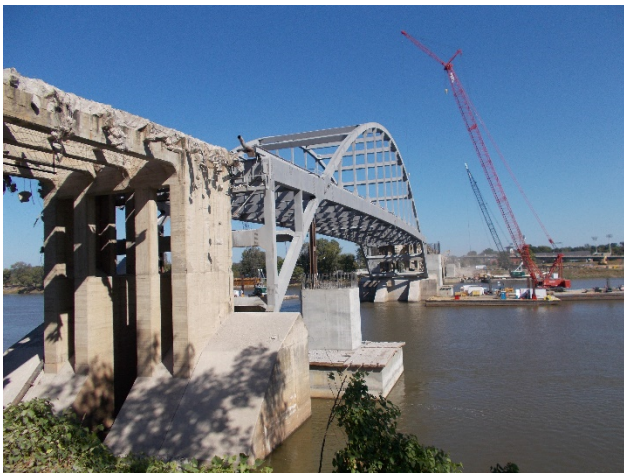
Figure 20 – Arch Support System

The use of explosive demolition was originally planned for the steel arch span. To protect the new pier below the arches, a

support system was designed to support the south end of the arches over the new footing while the remainder of the structure fell into the water. This system included temporary posts supported on the new pier, supporting the end of the arches. The end bearings of the arches were reinforced to provide the required support after the arches were cut. Locations of explosive charges were selected by others to break the structure into reasonably-sized sections that could later be picked from the river. The contractor was given a temporary waterway closure to bring down the span and remove the material from the river.

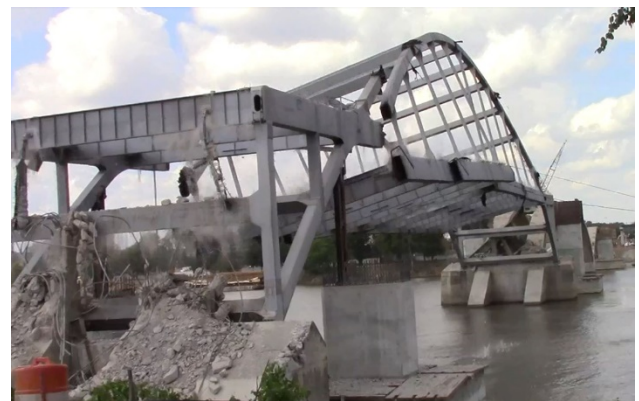
Figure 22 –Steel Arch Span

Unfortunately, the span did not fall following the execution of the explosive detonation and the structure remained in-place in a compromised state and in an unknown state of stability. Since the stability of the structure was compromised

Field staff were able to connect cables to the bottom chord member of the bridge and utilize barges to pull on the cables until the structure finally fell into the water. The bridge sections were lifted from the water as planned. The support system successfully held back the south end of the arch, even with the unconventional method of demolition.
