Replacing the MLK Street Bascule Bridge Toledo, Ohio

DAVID M. ROGOWSKI P.E., Genesis Structures, Inc., Kansas City, Missouri and JEFF KRACUN, National Engineering and Contracting Company (Balfour Beatty Infrastructure, Inc.), Canonsburg, Pennsylvania

IBC-07-81

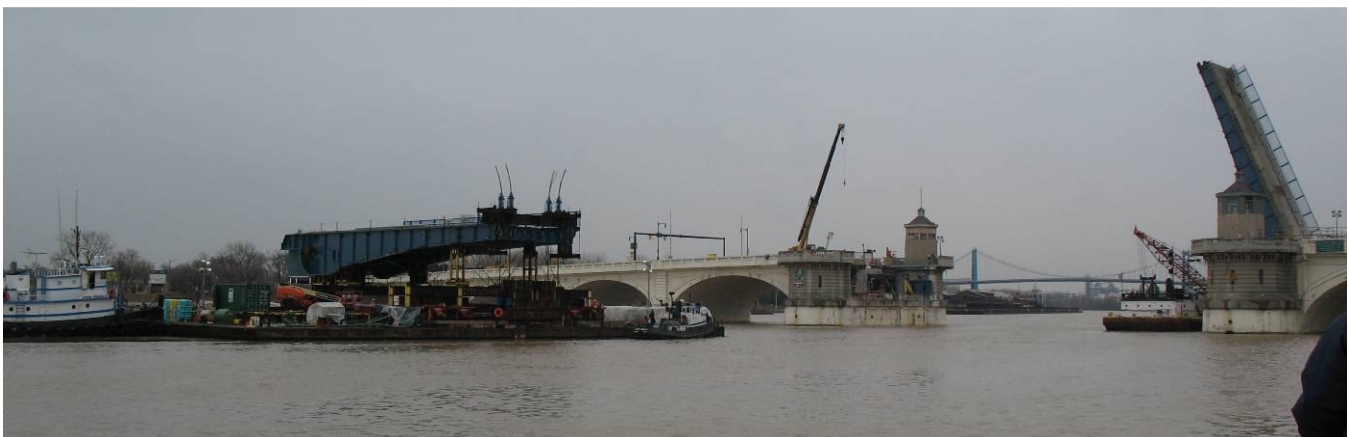
Site Photo – Second New Bascule Leaf is Floated into Position

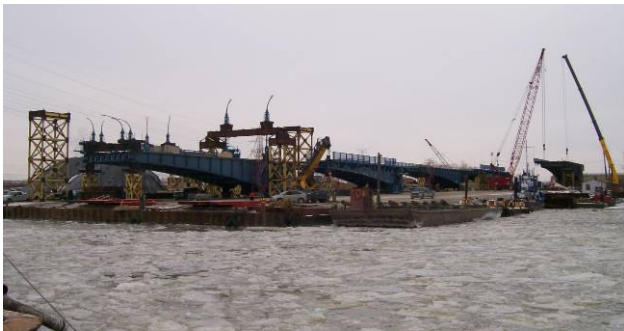
Time was the critical factor in many of the decisions made throughout the entire construction sequence. All repairs and modifications to the existing bascule piers and control towers that could be performed with the existing bridge in place were made months prior to the critical river outage period. In addition, steel erection for all four new bascule leaves was performed prior to the river outage at a staging yard 3 miles downstream from the bridge (see figure 1).

Figure 1 – Steel Erection in Staging Yard

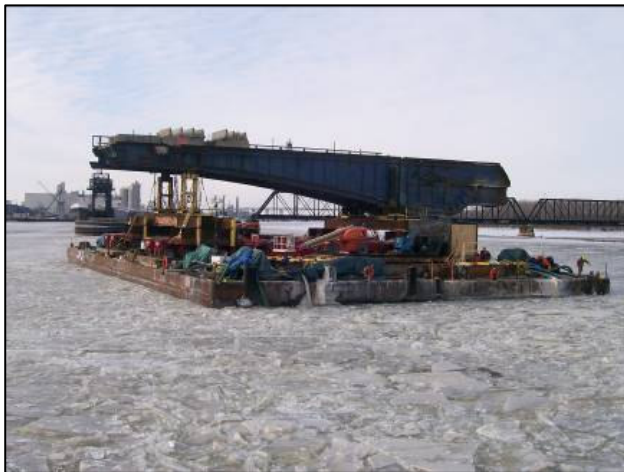
Navigating through the ice was accomplished with around the clock ice breaking operations. Those areas of the river not in the main navigation channel froze to thicknesses of 12 inches to 15 inches. Even with the ice breaking operations in process, large chunks of the broken ice would accumulate at the leading edge of the barge and the barge tow would occasionally find itself locked in the ice until the breakers could work around the perimeter and free it (see figures 3 & 4).

Figure 3 – Barge Locked in Ice

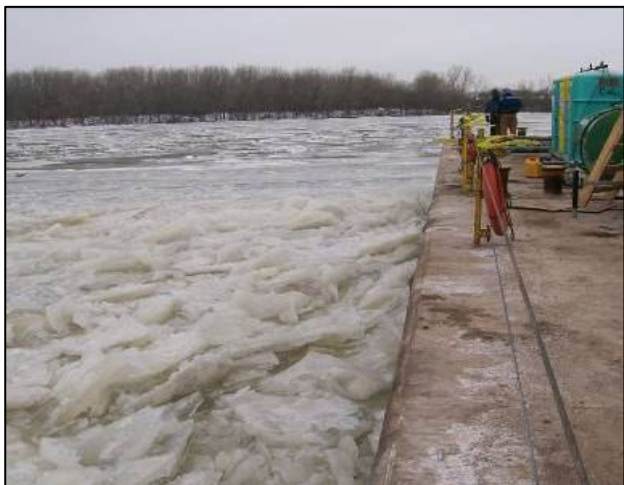
Figure 4 – Ice Accumulating at Lead Edge of Barge

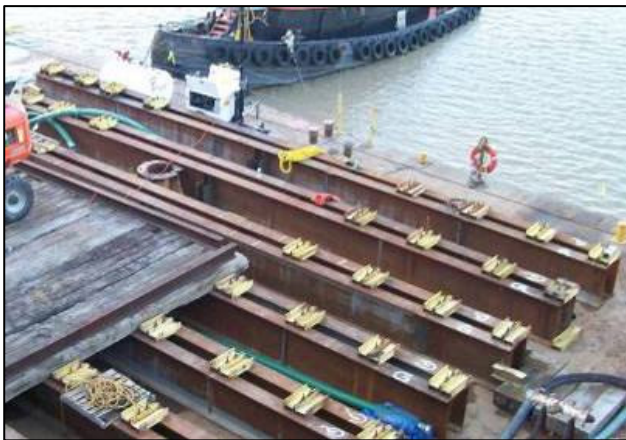
Linking two barges to act as one rigid barge required the use of 36 - W36x150 (Fy=50 ksi) spine beams overlapping each barge 28 feet. Each was bolted through the deck to the main transverse trusses (see figure 7). The barge shell and internal trusses were checked using a 3D finite element model (LUSAS Bridge Plus software) and all calculations were reviewed by the U.S. Coast Guard.

In addition to the spine beams, 1 inch thick diaphragm plates were added to the bow and stern to prevent any lateral shifts between the two barges while being pushed through the ice. The spine beams effectively bridged the gap between the two barges, the 1 inch plates locked the two barges laterally and the two individual barges performed admirably as a 100 foot x 180 foot rigid barge.

Figure 7 – W36x 150 spine beams linking barges

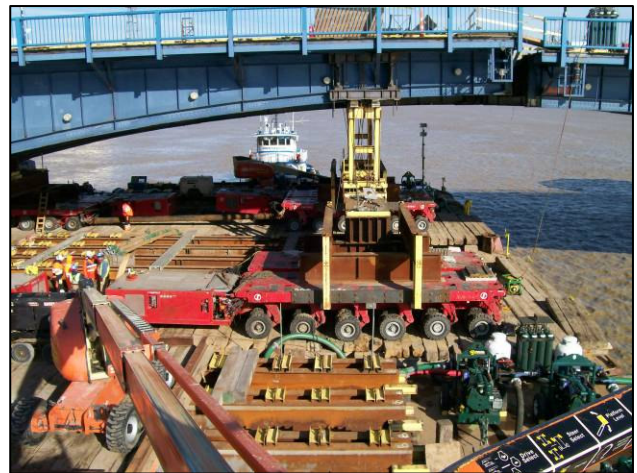
Removing the existing bascule leaves required the barge to be moored under the bridge while supporting the midspan "nose" of the individual leaf to be removed. The "nose" was lifted 18 inches to 24 inches to disengage the live load anchors located behind counterweight (see figure 8). This 3 inch to 4 inch gap was to be maintained until the bridge was ready to be lifted and removed from the pier. Water elevations were monitored every 15 minutes and the gap was maintained by adjusting the ballast within the barge or by adjusting the table heights of the SPMT's.

Figure 8 – "Nose" of bascule leaf lifted with barge

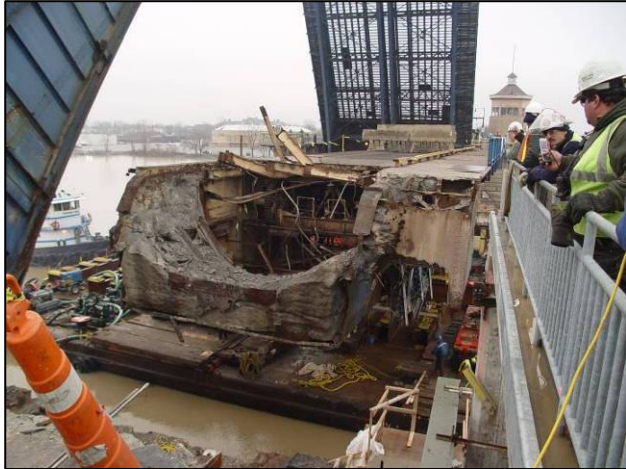
Removing the bascule leaf from the pier would require the demolition of the counterweight. Removal of the counterweight was dictated by the poor physical condition of the existing steel. Track hoes and excavators were used to rubbilize and remove the concrete. As counterweight concrete was removed, the "nose" reaction increased and further adjustments to the barge ballasting were made. The process to remove the counterweight concrete extended between three to four days. The construction team initially thought the entire concrete counterweight could be removed however limited positioning of the equipment affected the physical reaches and 15% (approximation) of the

counterweight concrete was left to transport out with the steel (see figure 9). Additional ballasting (concrete "Jersey" barriers) would be required at the "nose" to offset the large imbalance caused by the additional weight behind the pinion.

Figure 9 – 15% of the counterweight remained

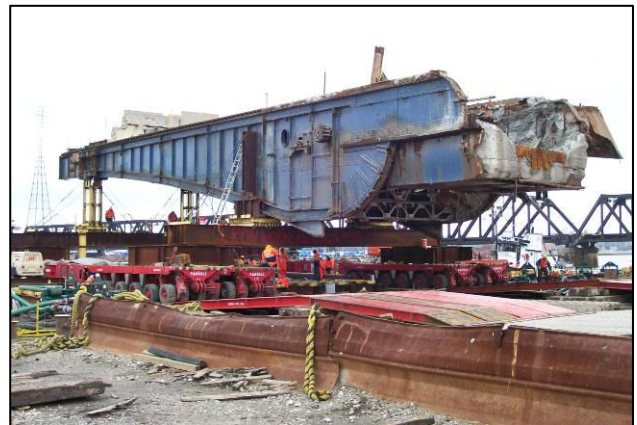
Disposing of the four existing bascule leaves was performed downstream back at the staging yard using cutting torches. After a two hour trip down the Maumee River, the barge with its cargo was moored and off loaded. To off load the barge, the SPMT's were backed onto ramps while carefully staged ballasting proceeded (see figure 11). The ballasting consisted of adding or shifting water in the barge to compensate for the weight shift as the SMPT's rolled off the barge and onto the ramps. A maximum 3 inch to 6 inch list was set as the design limits for operation.

Figure 11 – SPMT's backing onto ramps

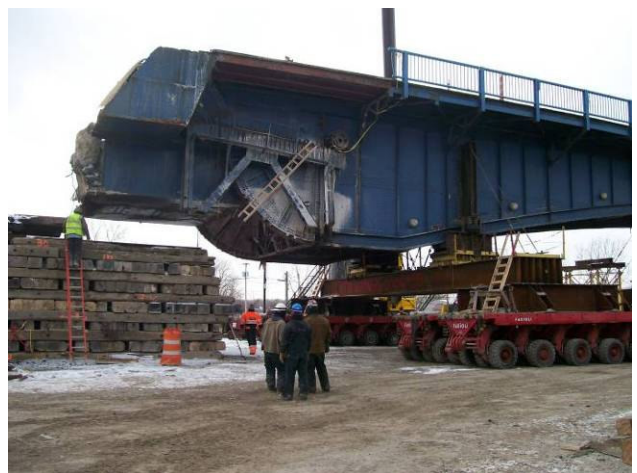
Once off the barge, the SPMT's were moved across the staging yard to a designated area set up with 12 foot stacks of oak crane mats. These would become the final resting place for the existing structure and the place where the bridges would be cut with torches and lances (see figure 12).

Figure 12 – SPMT's backing into mat cribbing

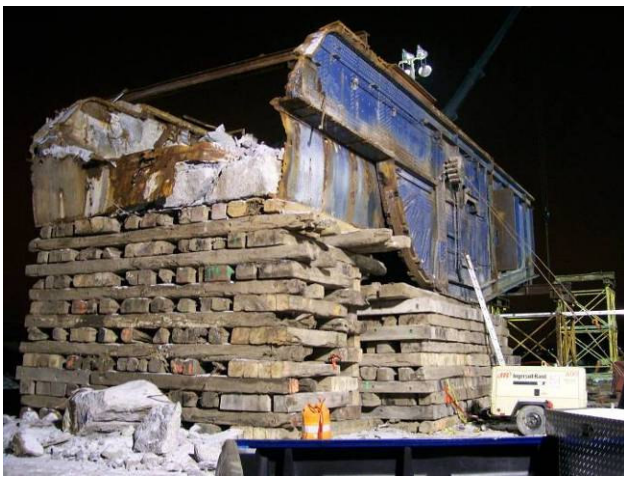
Landing the bascule leaf on the mats required synchronized shimming of the bearing points under the main girders and counterweight (see figure 13). Once seated on the mats, two 200 ton cranes were used lift the nose and allow the SPMT's to maneuver out from under the leaf. Once the SPMT's were clear, the nose was set down and secured to falsework towers. Once secure, the steel was cut using torches and lances (see figure 14). The machinery was removed first to recover all brass fittings followed by surgical removal of the steel working from the nose back towards counterweight. The remaining counterweight was rubbleized using track hoes.

Figure 13 – Timber mat cribbing under steel girders

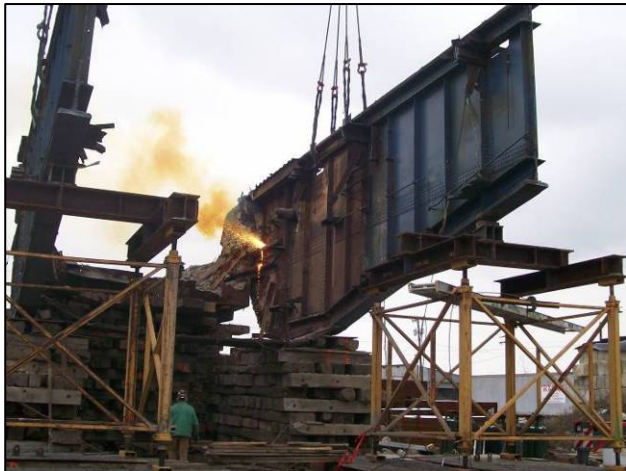
Figure 14 – Surgical type cutting using lances

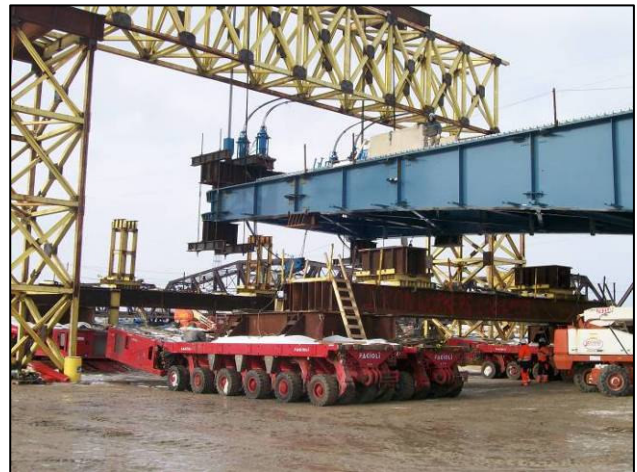
SPMT's onto the barge. All four new steel leaves were erected on falsework in the staging yard. Loading the SPMT's required the erected leaves to be lifted from the fixed falsework and then lowered onto the SPMT's. The new steel leaves were lifted using two 300 ton jacks mounted to an overhead gantry over the counterweight box, two 100 ton jacks mounted to a large gantry truss over the nose and four 100 ton jacks mounted to the nose of the new leaf (see figures 15 and 16). The new leaves were lifted 12 feet to clear the SPMT's and falsework cribbing. The SPMT's were positioned below the new steel however due to geometry restrictions, the back support was located 42 inches in front of the center of gravity of the steel leaf. 350 tons of steel counterbalance was suspended below the nose to offset the imbalance. The suspended steel would also serve as the additional steel required to be installed in the new counterweight once the leaf was at the bridge site (see figure 17).

Figure 15 – SPMT's under front gantry truss

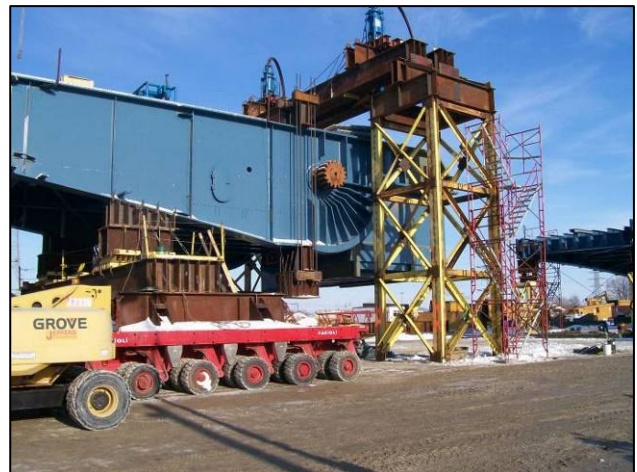
Figure 16 – SPMT's under back gantry

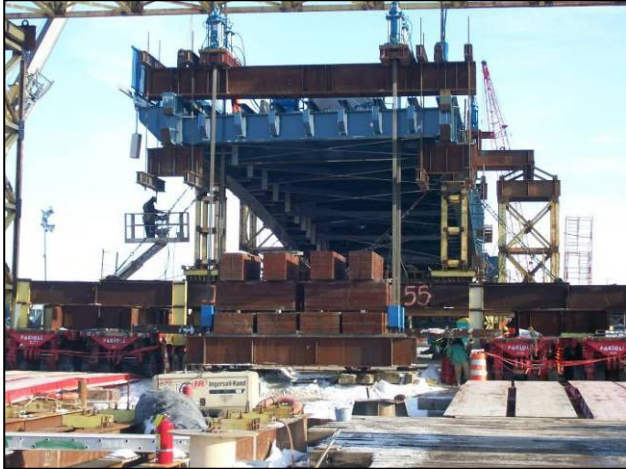
Figure 17 – 350 tons of counterbalance at nose

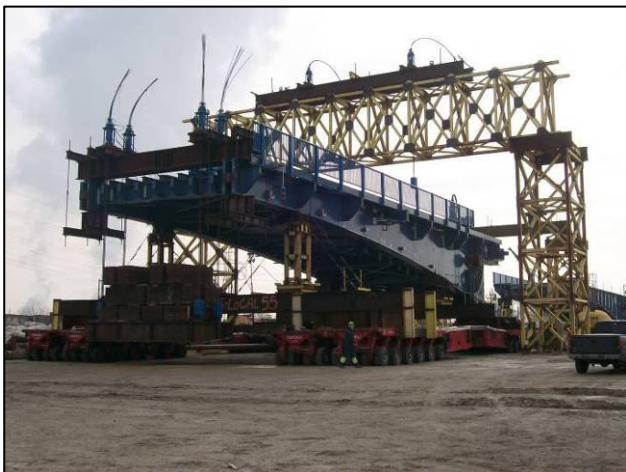
Once loaded onto the SPMT's, the new leaf was secured to the cribbing with cable rigging. After the leaf was secured, the SPMT's were moved out from under the gantries and back across the staging yard to the moored barge (see figure 18). The new leaf and counterbalance weighed 300 tons more than the old leaves and the load distribution was very different than the old leaves; therefore a new staged ballasting sequence was required. To load the new leaf, the barge was ballasted to the exact weight of the combined new leaf, counterbalance and SPMT's. The SPMT's were then moved "nose" first onto ramps (see figure 19). Ballast adjustments consisted of removing and shifting water in the barge to compensate for the additional weight as the SMPT's rolled onto and across the barge. A maximum 3 inch to 6 inch list was set as the design limits for operation.

Figure 18 – SPMT's move out from under gantries

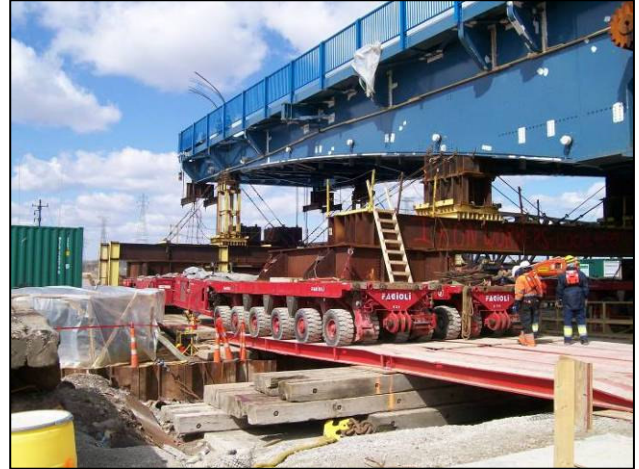
Figure 19 – SPMT's roll "nose" first onto barge

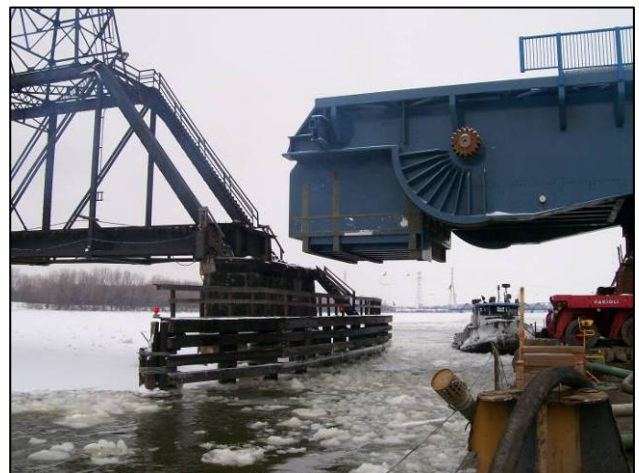
Installing the new leaves required another trip back upstream. The new bascule leaves were heavier and the counterweight boxes were deeper than the existing leaves. One obstacle on the river (a 300 foot railroad swing span bridge with 135 foot navigation clearances) created a unique challenge as the new bridge could only pass over the existing pier when the water elevations were at normal datum or higher (see figure 20). The installation of one leaf was delayed one day due to low water elevations.

Figure 20 – Tight clearances at existing RR bridge.

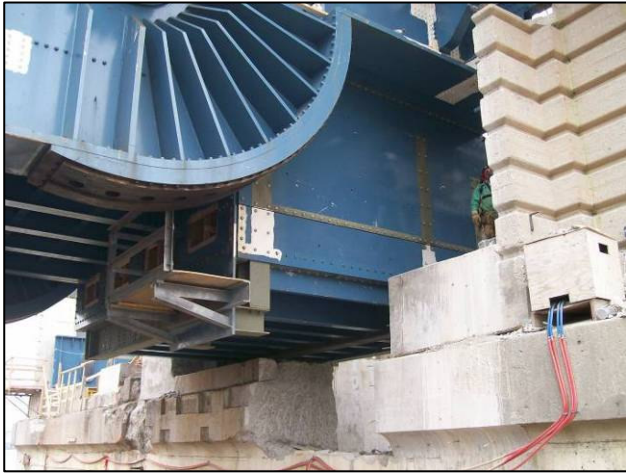
Once the new bascule leaf arrived at the site, the barge was moored to another spud barge while final alignment (up and down stream) was set. Final alignment was achieved with the use of a telescoping arm that when fully extended made contact with a preset guide anchored to the face of pier. Two deck winches were used to guide the barge towards the pier. The initial fit up was made

using the deck winches (see figure 21). Clearances at each side and top and bottom were tight with the largest clear gap at 3.5 inches and smallest at 1.5 inches. Final fit up with the pintels and gear teeth was made using the fine motor movements of the SPMT's (see figure 22).

Figure 21 – Initial fit up of spans

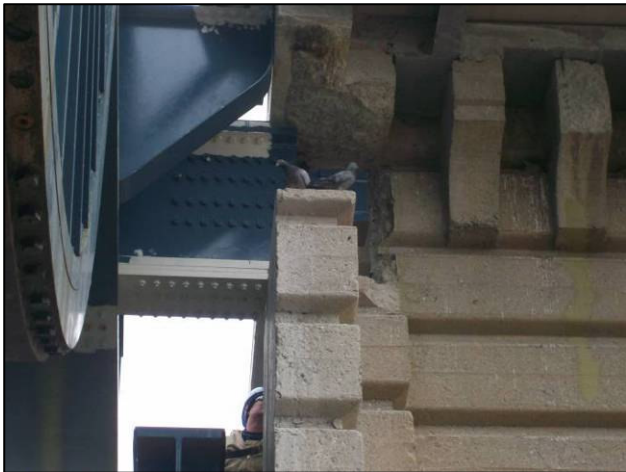
Figure 22 – Final fit up of spans

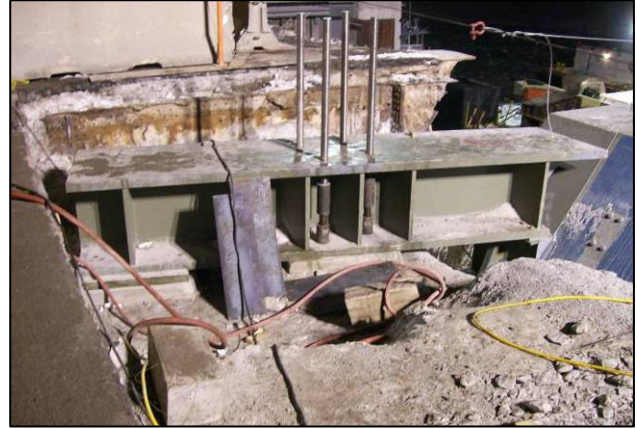
Once the bridge was aligned with the pintels and gear teeth, the new live load anchors were installed and post-tensioned (see figure 23). While the live load anchors were installed, only 20% of the load could be transferred to the pier without tipping the leaf into the river. During this period, water elevations were checked every 15 minutes and ballast adjustments were made to the barge to compensate for large changes in the water elevation or to the SPMT table height for the more immediate and smaller changes in the water elevation.

Figure 23 – Installation of live load anchors

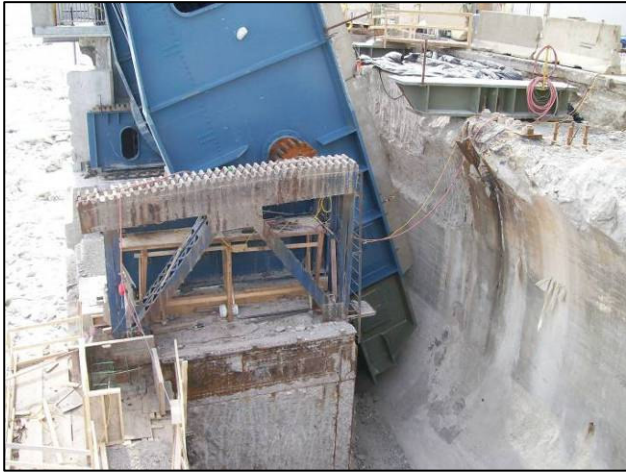
Figure 25 – Bridge opened during machinery tests
