Replacing the Memorial Bridge

DAVID ROGOWSKI, P.E. AND JOSH CRAIN, Genesis Structures Inc., Kansas City, Missouri and STEPHEN DELGROSSO, Walsh Construction Company, Canton, Massachusetts

IBC-14-16

KEYWORDS: Vertical Lift Bridge Replacement, Barge Stability, Gusset-Free Steel Truss Erection, Accelerated Bridge Construction

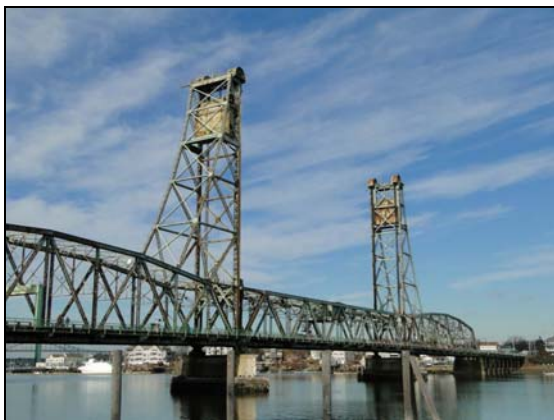
Figure 1 – Original Bridge taken out of service to vehicular traffic in 2011

The original Memorial Bridge was erected in 1923 and served the City of Portsmouth, New Hampshire well as a major vehicular and pedestrian link to nearby Kittery, Maine. The innovative original three-span structure (See Figure 1) was designed by the patent holder for the first modern vertical lift bridge, J.A.L. Waddell.

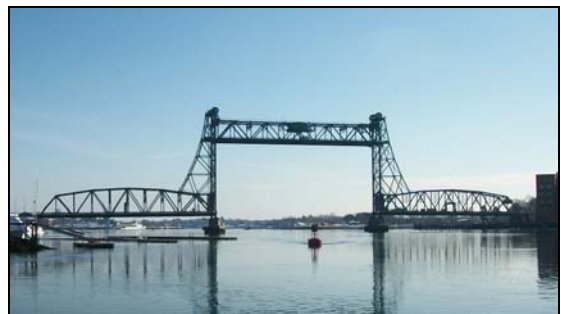
Figure 2 – Bridge still able to perform daily lift activities

The deficiencies of the original bridge were of no fault to the movable bridge design aspects of the original structure. The 300-ft vertical lift bridge was able to perform daily lift activities flawlessly from a mechanical perspective; however, neglect of the floor framing and lower truss chords had allowed

deterioration beyond repair (See Figure 2). Similar deterioration (See Figure 3) was seen on the two adjacent 300-ft fixed spans, and eventually the bridge was taken out of service to vehicular traffic in July of 2011.

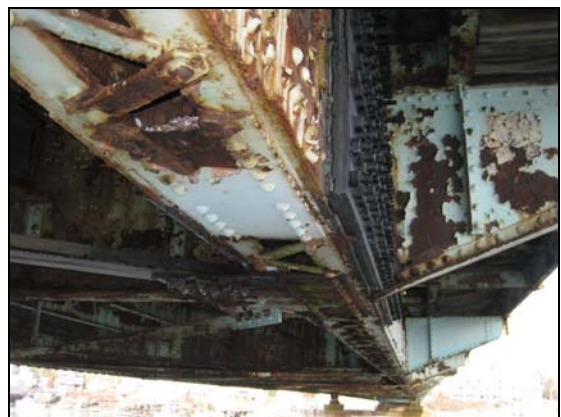
Figure 3 – Deterioration of lower chord and floor system
After extensive research and community outreach,

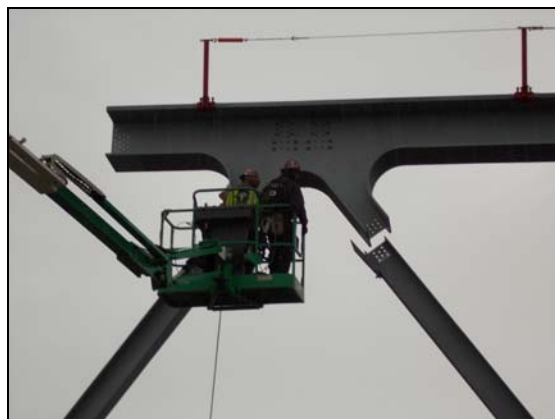
Figure 4 – Cold-formed steel Gusset-free truss reduced quantity of bolts per connection

The Walsh Group¹ Design Build Team won the honor to build the new bridge as part of a creative design build selection process. The Walsh team included HNTB as their designers and Genesis Structures as their erection engineer. All three worked to develop a structure type and erection method that would not only satisfy the design requirements, but also the limited construction time-line. The final replacement bridge structure selected was a cold-formed steel “gusset-free” truss (See Figure 4 and Figure 5). Advantages to this “gusset-free” design over the conventional truss were both to avoid potential costly future gusset retrofits due to corrosion and to minimize the quantity of bolts used per connection, making it faster to erect and easier future maintenance.

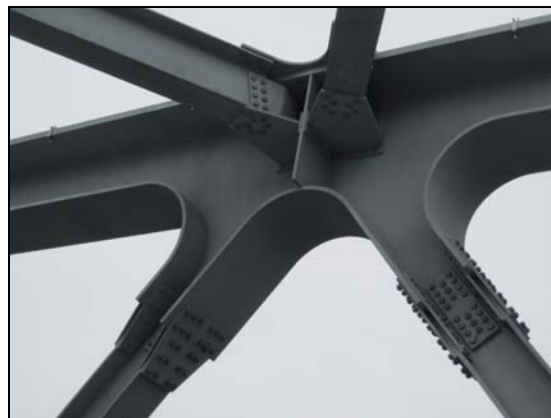
Figure 5 - New “Gusset-free” truss upper chord and diagonal connection

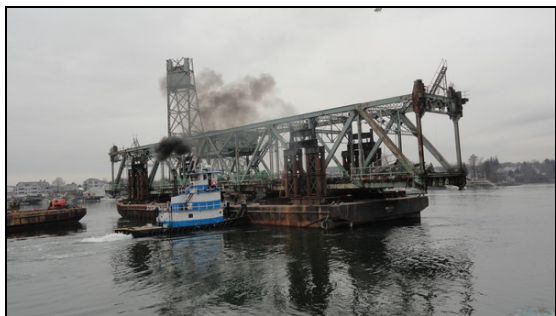
Figure 8 – Lift Span removed and supported on barge

The first and most critical truss span removed was the 1,800 kip, 300-ft vertical lift span (See Figure 7 and Figure 8). The importance of the lift span removal was due to the complexity associated with simultaneously supporting (or having control of) both the lift span and the two 900 kip concrete CTWTs (See Figure 10). Due to the high risk and critical nature of the lift span removal, a falsework tower system, capable of +/-20ft of vertical stroke was utilized to move the lift span. The falsework tower system was supported by a single 250-ft x 72-ft ocean going barge (the sea vessel lovingly named the “Cape Cod”).

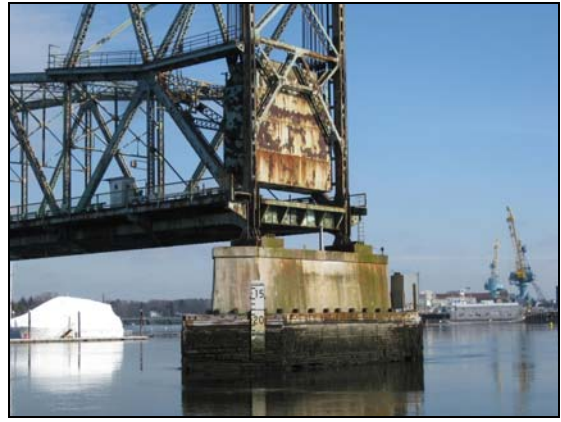
Figure 9 – 900 kip Concrete CTWT prior to demolition

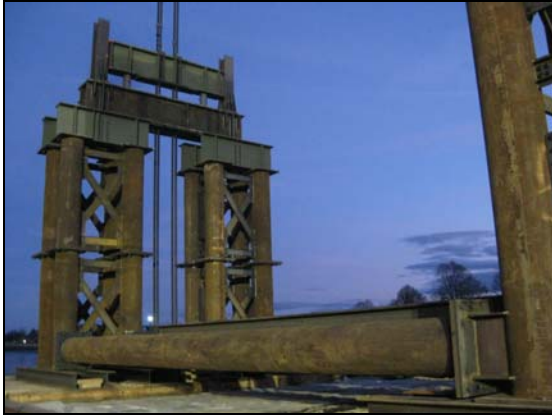
Figure 10 – Falsework Tower System for float-out of Existing Lift Span Truss

The existing lift span truss was picked up by the float out falsework at thoroughly inspected interior panel points which were determined to require no additional local strengthening. The falsework tower system, used at each pick point of the existing truss, was comprised of (4) Tower “Jacking Corners” (See Figure 10). Each Tower “Jacking Corner” was comprised of a multi-level “jacking beam” system power by (2) 400-T hydraulic jacks. The elevation of the “jacking beam” system was adjusted with the use of (4) 2-1/2” 150 ksi Williams All-Thread Rods.

The “jacking beam” systems were supported on each end by a (4) 24” diameter pile tower groups. The 24” diameter tower piles rested directly on HP cribbing, this steel cribbing transferred the load to the barge deck through crane mats resting on a confined 12” “sandbox” poured directly on the barge deck.

The stability of the (4) 24” diameter pile tower groups were provide by an additional 24” diameter pipe “strut” located at the bottom of the tower piles just above the HP cribbing (See Figure 10).

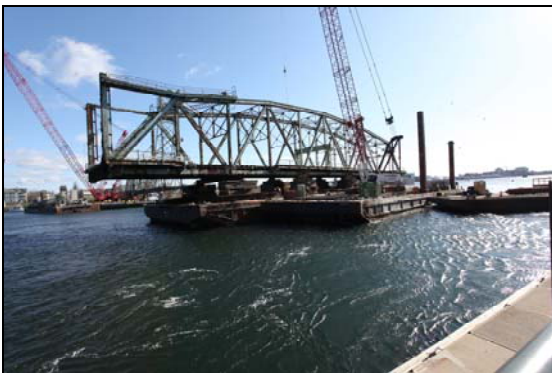
Figure 11 – Fixed Span removed and supported on barge

The following (2) 300-ft fixed spans were float-out with a much less intricate falsework tower system (See Figure 11). The towers used to float out the existing lift span, capable of +/-20ft of vertical self adjustment, were replaced with stacks of hardwood mats resting directly on the barge deck. The power of the river’s tide was relied upon to take the load and lift the existing fixed trusses off their bearings. Relying on the power of nature is always the preferred method; however, risk and potential consequences due to complication during removal must always be considered.

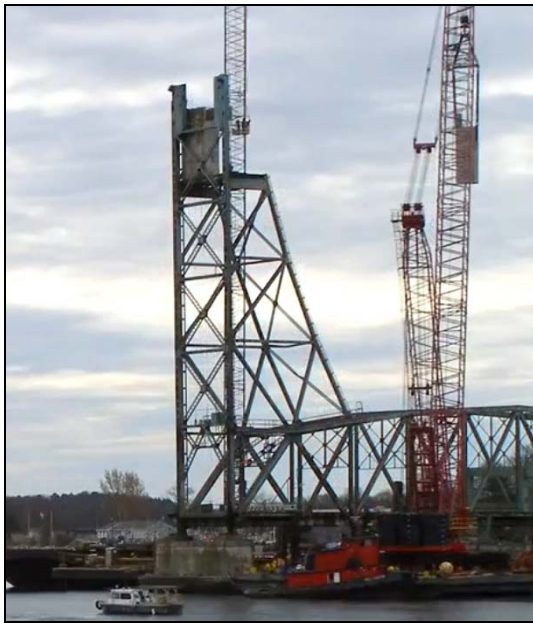
Figure 13 – Existing CTWT removal

TOWER AND CTWT REMOVAL – The 200-ft vertical lift towers and (2) 900 kip CTWTs were removed outside of channel closures. The CTWTs were supported on newly installed cribbing beams spanning the existing tower’s CTWT support girders. The CTWTs rested on these newly installed grillage beams during the lift span removal and until the CTWT was surgically removed. Genesis Structures performed a finite element stress analysis (FEA) (See Figure 12) to determine temporary stress in the CTWTs during the lifting removal operations (See Figure 13). The lift tower was also removed surgically with the use of cranes on barges.

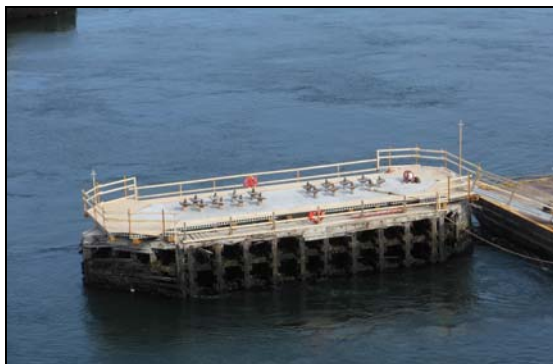
Figure 14 – Existing Pier after span float-outs, strengthened for reuse with new bridge

The existing pier foundations were reinforced with micropiles (See Figure 14 and Figure 15) and new Pier Caps were cast over the top of the reinforced existing foundations. This “reinforcing” process of the existing substructure was completed in a 7-month period from May 2012 to January 2013.

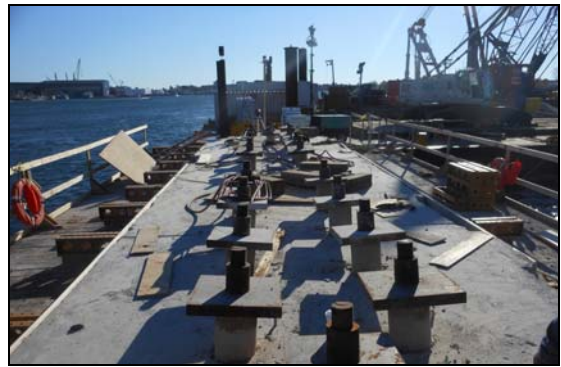
Figure 15 – Micropiles installed in existing foundations

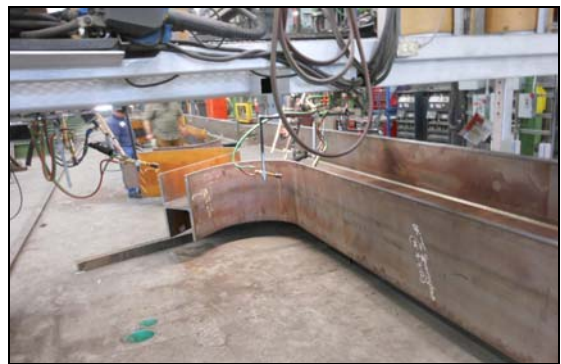
Figure 16 – Cold-formed steel truss chords shown during fabrication

NEW TRUSS FABRICATION – The new truss’ “gusset-free” design got its first opportunity to prove its merit in the fabrication phase. With the truss’ gusset plates removed, the diagonals connected to the top and bottom chords with a more conventional splice connection. The splices were located up in the diagonal; the chords therefore had to be designed to accommodate these splices. In order to accommodate this complex geometry, the truss was fabricated entirely from 50 ksi or 70 ksi cold-formed steel (See Figure 16).

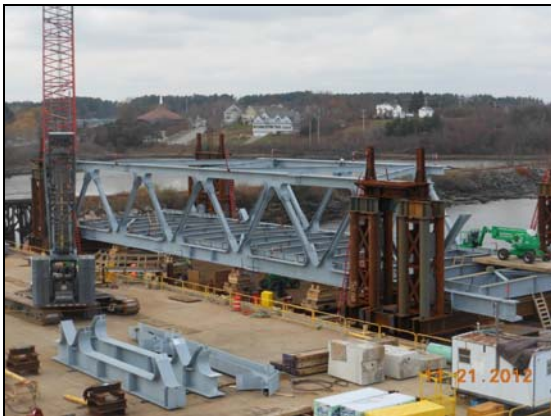
Figure 17 – New Fixed Span Truss partially erected on Cape Cod Barge

TRUSS ERECTION ON BARGE – As soon as a new truss was fabricated, the truss components were immediately moved to the job site staging area and erection of the new trusses on the same barge used for the existing truss float-outs, the Cape Cod, was set in motion (See Figure 17)

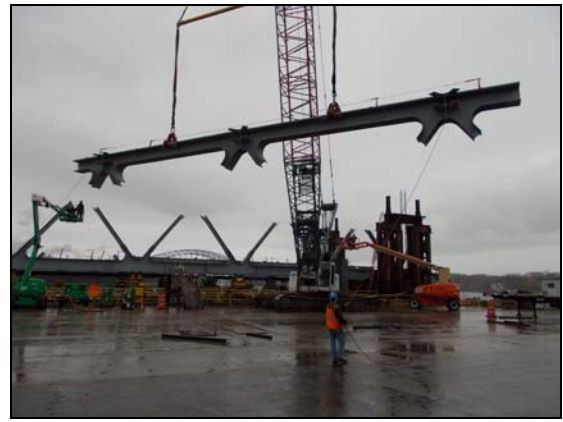
Figure 18 – Top chord segment installation

The new trusses were built one-at-a-time on the Cape Cod, starting with the New South Fixed Span. Genesis Structures performed all of the barge stability analysis, falsework design and rigging analysis required during the truss erection operations. The center of gravity calculations proved complicated at times due to the unique nature of the truss chord geometry (See Figure 18).

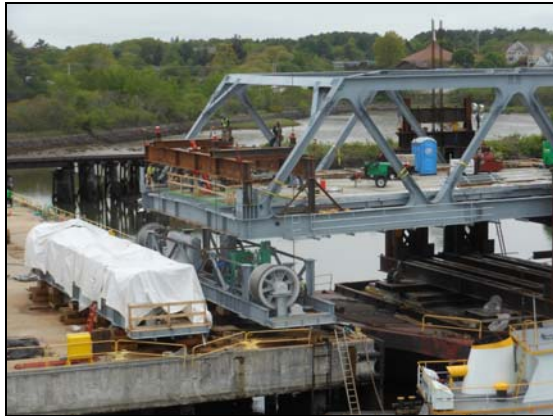
Figure 19 – Machine Room prior to installation, Jacking Grillage installed on Lift Span

Genesis Structures and Archer Western Contractors went through several iterations to determine the appropriate machine room lifting plan. The final method utilized a jacking grillage system supported directly on the bottom chords of the previously erected lift span (See Figure 19 and Figure 20)

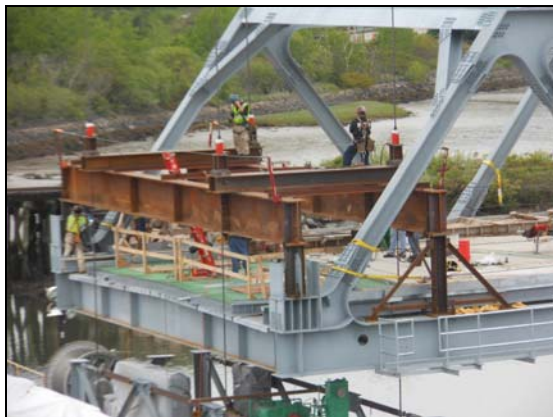
Figure 20 – Jacking Grillage for machine room lift, grillage supported by bottom chord of New Lift Span Truss

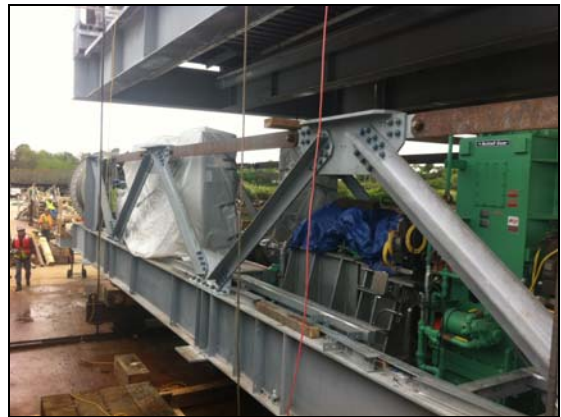
Figure 21 – Machine Room Truss “Temporary” Top Chord utilized during machine room lift

During lifting operations, because the machine room truss was supporting the full weight of the mechanical systems and was without a top chord, a “temporary” erection top chord had to be installed on the machine room truss. The “temporary” top chord had to be stiff enough to maintain the machine room truss’ geometry, allow for in-the-field adjustments to geometry, as well as not

interfere with the permanent machine room top chord (the end floor beams). A “temporary” top chord consisting of bar plate and two end 2.5” diameter turn buckles was used.

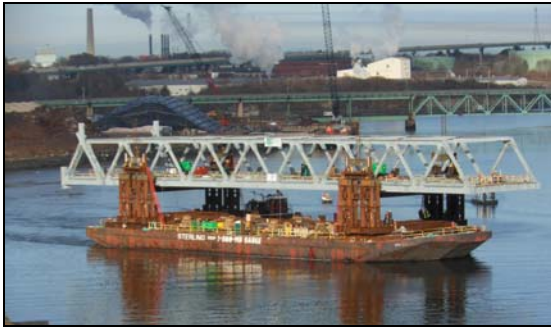
Figure 23- New South Fixed Span en route to bridge site

NEW FIXED SPAN FLOAT-IN PROCEDURES – The first new truss spans installed were the South and North 300-ft fixed spans (installed in January and March of 2013 respectively). The float-ins took place during slack tide when the current on the river was changing direction. These short durations in the tide cycles allowed the barge to be transported and positioned with slower currents. The trusses were installed during varying stages of erection. The first span installed, the South Fixed, was floated in with only a small portion of the vertical lift tower components erected (See Figure 23).

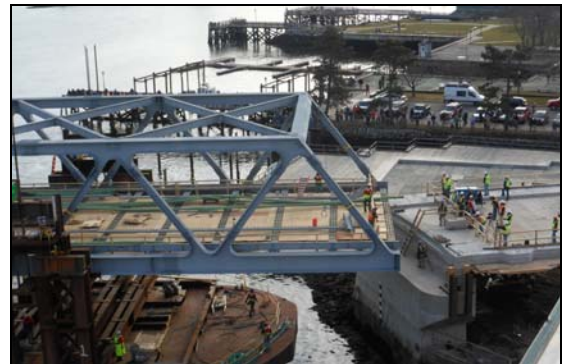
Figure 25 – South Fixed Span Truss rotated into position to set down on permanent bearings

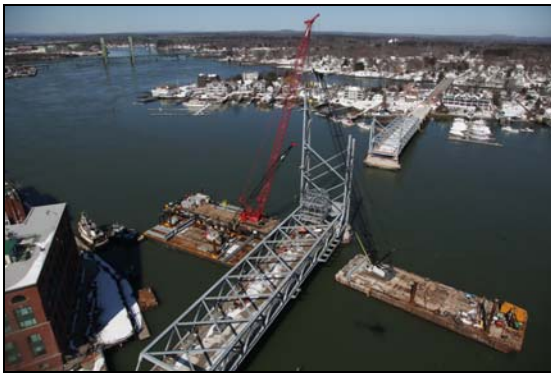
Figure 26 – Lift tower construction of South Fixed Span

LIFT TOWER CONSTRUCTION – The completed Lift Towers would provide 150-ft of clearance above high tide while the lift span was raised. The construction of these towers began immediately after the fixed span trusses were installed. The towers were stick built using cranes to move the tower segments into position (See Figure 26). The vast majority of the splices were field bolted by hand. The iron workers, performing the splice connections, utilized "tower-float" access platforms that were connected directly to the falsework tower member being spliced (See Figure 27).

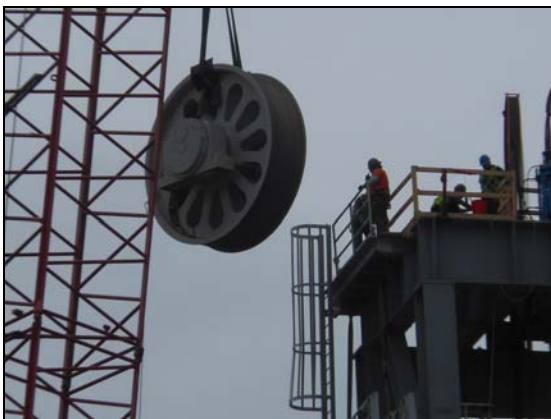
Figure 28 – Installation of 11’-2” Diameter Lift Tower Sheave

The lift towers were outfitted with a “Push-pull Jacking” system installed at a lower splice of both tower back legs. The “Push-pull Jacking” system was bolted to the tower legs and would accommodate up to $\pm \frac{3}{4}$ ” of adjustment as required to plumb the lift towers once the 11’-2” diameter sheaves (see Figure 28) and 1,250 kip CTWTs were installed. The bolt holes for the final splices (at the “Push-Pull Jacking” locations) were field drilled once tower alignment was satisfied and the “Push-Pull Jacking” system was removed.

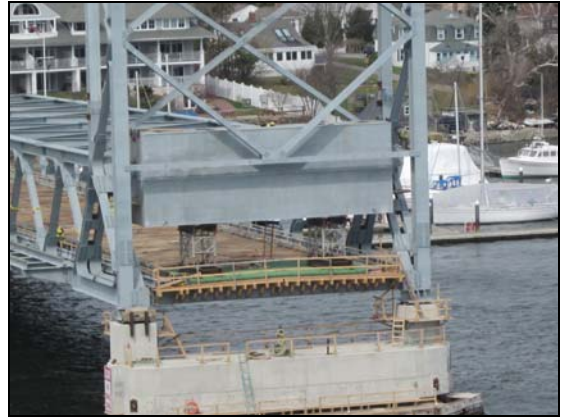
Figure 29 – New CTWT constructed on installed fixed span

CTWT CONSTRUCTION – The concrete CTWTs were constructed on falsework towers located directly below the permanent CTWT alignment and supported by the installed fixed spans. Construction of the 1,250 kip CTWT began immediately following the spans installation and even before the bridge deck had been poured (See Figure 29).

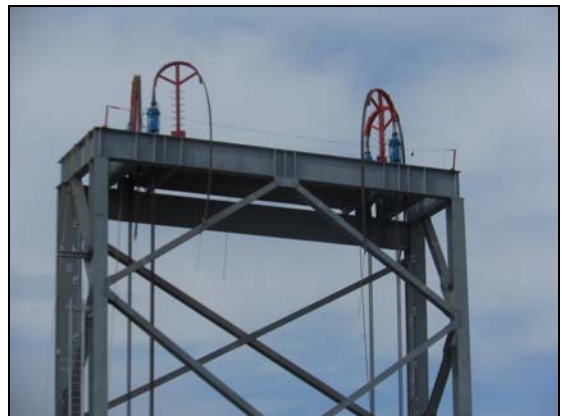
Figure 30 – Strand Jacks Supported by upper lift tower framing

The CTWTs were built directly below their final position. They were hung in place with (4) 180-Tonne strand jacks supported directly by the upper lift tower framing (See Figure 30 and Figure 31) and filled with concrete and steel before they were hoisted to the top of the towers. Once the CTWTs were supported by the lift towers, Genesis Structures and Archer Western worked closely to compare tower alignment survey data with anticipated design models. All required final tower adjustments was a coordinated effort between Genesis Structures, HNTB and Archer Western.

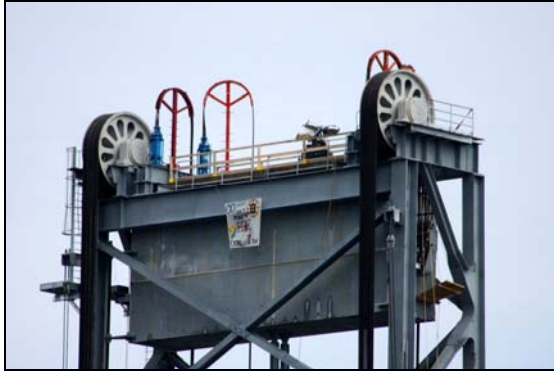
Figure 31 – CTWT in final lifted position, supported by strand jacks

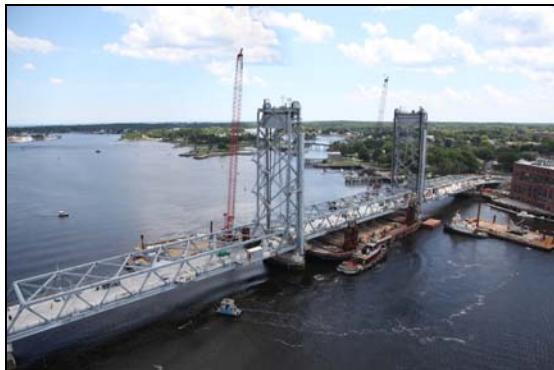
Figure 32 – New Lift Span installed prior to being released by float-in barges

LIFT SPAN FLOAT-IN – The 300-ft Lift Span was floated in June of 2013. The lift span installation occurred once the lift towers had been fully erected and the CTWTs were lifted into position and supported by the strand jacks. With the machine rooms installed and the lightweight concrete deck poured, the lift span weighed a total of 2,500 kips during float-in.

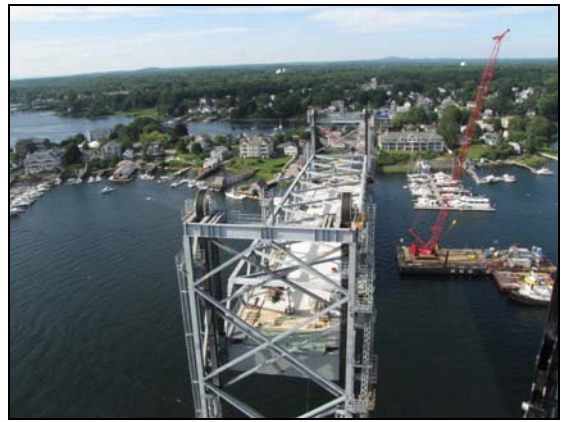
Figure 33 – Adjustments to lift tower continued after lift span balanced and installed

Once floated in, the new lift span truss was placed on load cells to measure the final truss weight to confirm balance with the CTWTs. All final balance and tower alignment adjustments were again a collaborative effort between Genesis Structures, HNTB and Archer Western.
