# Construction and Span Replacement for CSX Bridge 64 Crossing North Branch of Potomac River

John Boschert, P.E., S.E., Genesis Structures, Inc., Kansas City, MO  
Matt Struempf, P.E., OCCI, Inc., Fulton, MO

IBC-16-44

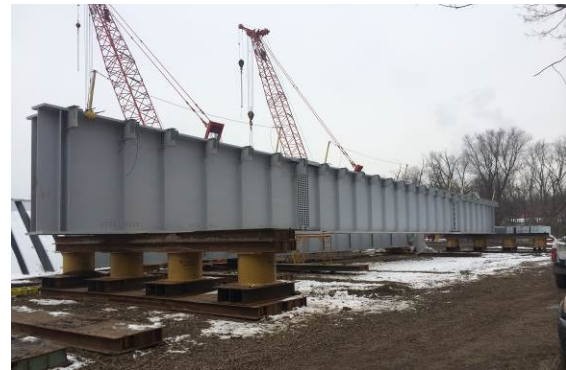
Figure 7 – Span 2 Girder Pre-Assembly

Single girder segments were trucked to site in 70ft and 40ft sections. Span 2 was pre-assembled into girder pairs 150ft in length.

These girders were assembled full length to eliminate the need to install any temporary erection bents in the river channel. Span 1 was pre-assembled into girder pairs.

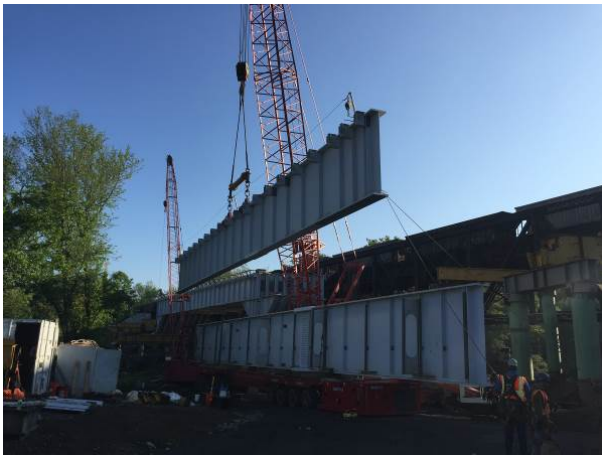
Figure 8 – Span 3 Unloading Off of SPMT

The girders were not pre-spliced for this span due to the limited space available for working on the Maryland side of the bridge. Span 3 was set as 110ft single girders and 40ft girder pairs.

Span 2 and the 110ft sections of Span 3 were assembled on elevated platforms to permit the sections to be moved from the laydown yard through use of Self Propelled Modular Transporters (SPMTs) without having to use cranes to load the segments.

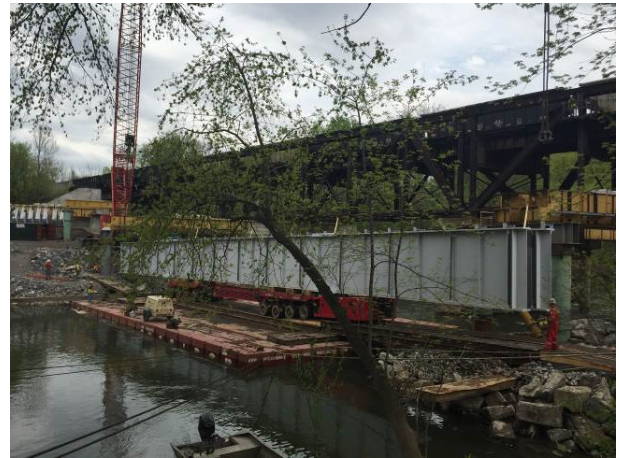
Figure 9 – Girder Transport on SPMT's Supported by Sectional Barges

**TRANSPORT OF PRE-ASSEMBLED GIRDER UNITS** – Once pre-assembly of the girder segments was completed, the segments were moved to the erection location through use of SPMTs. Span 2 segments were loaded onto an 8-line unit with a spacer beam. The spacer was needed to maintain stability of the system during transport. The Span 2 segments were transported out onto a set of sectional barges in the river. A barge stability - floatation analysis was completed to determine the barge size and ballasting needed for rolling the spans out onto the barge.

For transport of Span 1 segments, the spacer beam was removed and the deck of the barges was reconfigured to act as a floating bridge for transport of the segments across the river. The shorter transporter length was needed in order to allow the SPMT to traverse the steep slope on the Maryland side of the bridge. The Span 1 segments were transported one at a time across the floating platform to the Maryland side of the site.

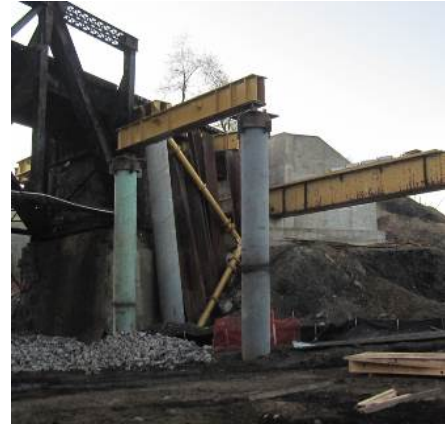
Figure 12 – GEFB Structure In-Use

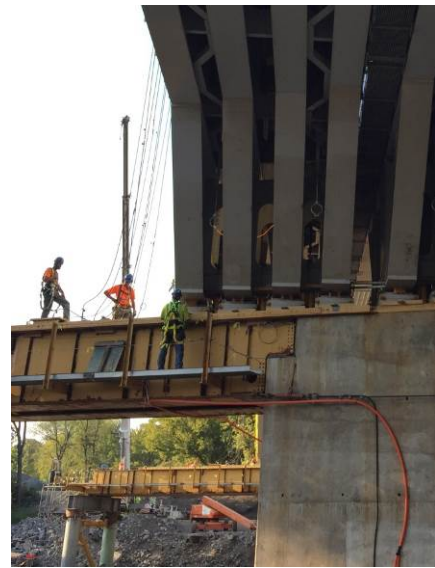
Figure 16 – Pier Modification for Support of Falsework Structures

Pre-existing 50'-long box girders were utilized to support the required loads. On the downstream side, the design of the new pier elements was modified to support the box girders. On the upstream side, the box girders were supported on large pipe pile and pile caps.

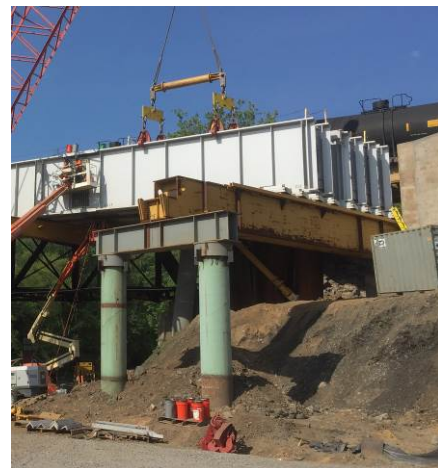
Figure 17 – Falsework Structures at Abutment

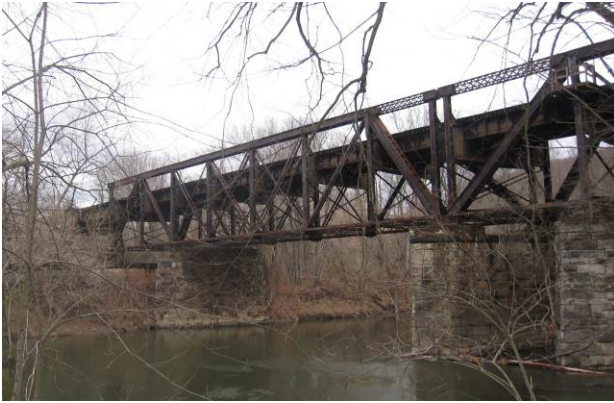
Figure 18 – Existing Truss Span

The existing bridge included two double-track through Pratt truss spans, each 166' long.

Significant planning and engineering were involved prior to moving the existing truss spans. Although construction plans for the bridge were available, there was limited detail and there appeared to be significant variations from the plans. The 19° skew and elevated deck truss configuration presented challenges for the construction team.

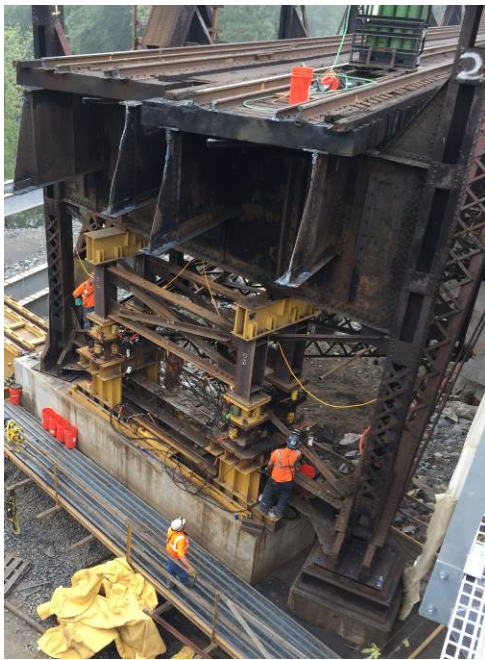
Figure 21 – Truss Lifting Frame Photo

**LIFTING FRAMES FOR SLIDING** – The truss was lifted at the end floorbeams using custom-designed and fabricated lifting frames, supported on a powered sliding system. The lifting frames were designed around the existing truss geometry because they had to be installed in advance of the track closure with the bridge remaining in service following installation. The lifting frames also had to accommodate the vertical jacking system and remain stable during the lateral slide.

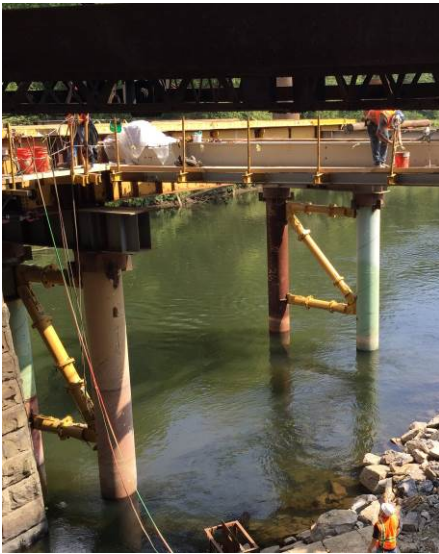
Figure 25 – Temporary Structure for Sliding Existing Truss Slide-Out

**FALSEWORK STRUCTURES FOR SLIDING –** Similar to the falsework structures used for the new girder erection, significant temporary structures were designed and constructed for use in supporting the existing truss structures during the slide-out. These falsework structures were aligned with the existing bridge piers such that the lateral slide could transition along the alignment from the existing piers to the temporary structures. This activity required modifications to the existing piers which varied by location. The Maryland Pier and the River Pier required concrete in-fill achieve a sliding surface. The West Virginia abutment required low-profile profile adjustments to achieve a smooth surface.

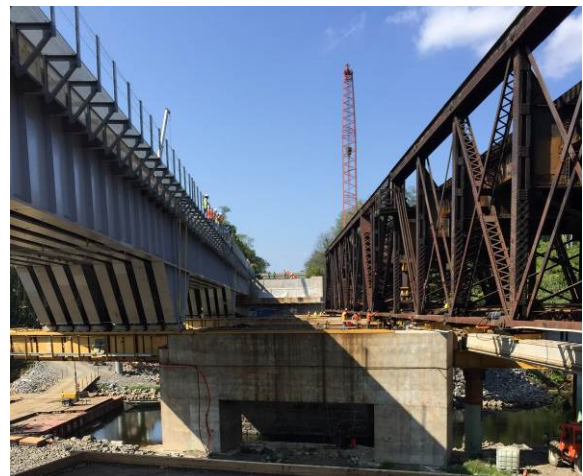
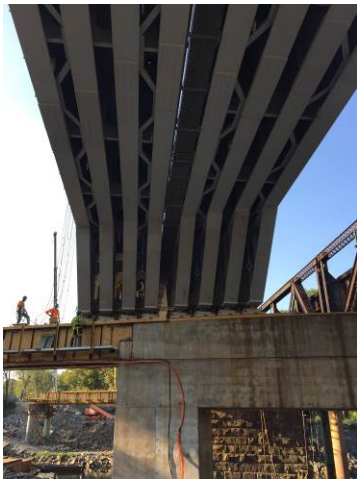
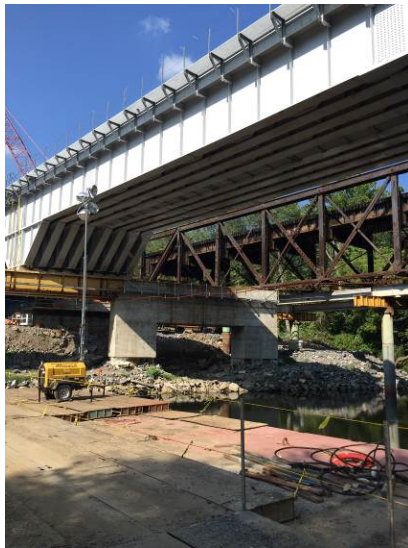
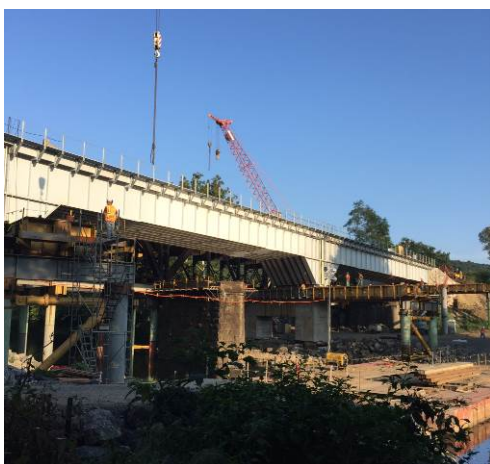
Figure 29 – Span Change-out

Figure 31 – Span Change-Out

Figure 32 – Span Change-Out

Figure 33 – Span Change-Out

**EXISTING TRUSS LATERAL SLIDE-OUT** – As soon as the MD approach spans that framed into the truss were removed, lifting of the existing truss began. This operation was completed with a combination of 50TN and 100TN hydraulic jacks. Total lift was 8". Once the bearings were lifted high enough to bring in the slide track, the area under the bearing was grouted to a level condition and the slide tracks were installed. Total time from the start of lifting operations to being ready to slide out was 7.5hrs.

The Hydraulic Power Units (HPUs) were then switched over to the push cylinders of the slide system. Sliding the truss spans out was accomplished in just under two hours. Total slide distance was 47ft.

**NEW SPAN LATERAL SLIDE-IN** – After the existing truss was slid out the HPUs were switched over to the push cylinders for the new DPG spans. All three DPG spans were moved simultaneously 39ft into their final position. Sliding all three spans at the same time allowed for all of the walkways to be complete and for the track to be pre-installed and spliced on the deck prior to the outage. Total time to slide the new spans and align them was 3.5hrs.

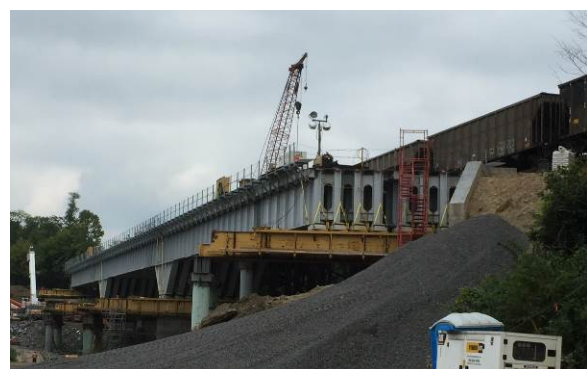
Figure 30 – New Steel Ready for Change-Out

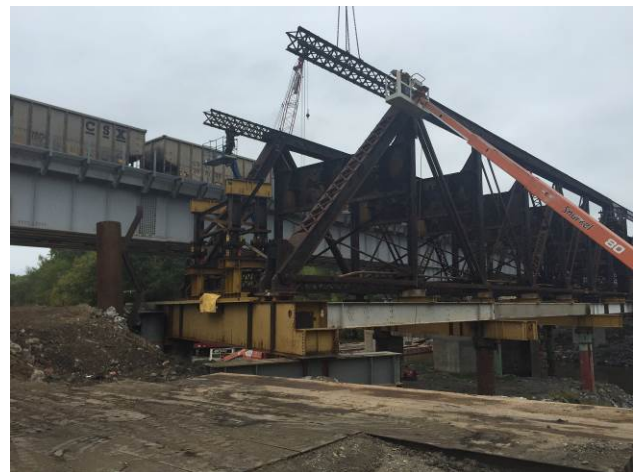
Figure 34 – Beginning Truss Demolition

Demolition of the truss occurred simultaneously on both sides of the river working from the abutments towards the center pier. In order to keep the cranes close enough to the work, the demolition falsework was removed as work progressed.

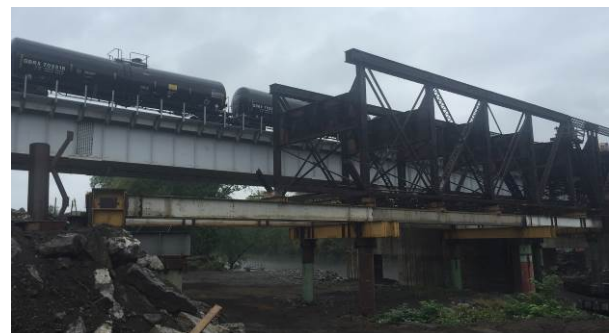
Figure 35 – Progressing Truss Demolition

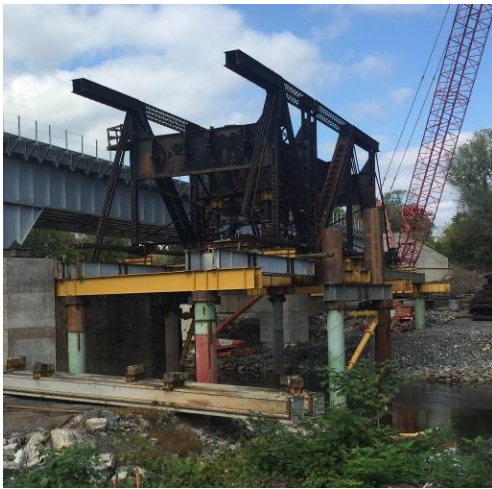
Figure 36 – Truss Demolition Nearly Complete
