Replacement of the TRRA Merchants Truss Spans – Face Lift for a 120-Year-Old Bridge

JOSH CRAIN, P.E., S.E, Genesis Structures Inc., Kansas City, MO, ROB NEVILLE, Walsh Construction, Chicago, IL, MATT BOBEN, Mammoet USA

IBC 22-81

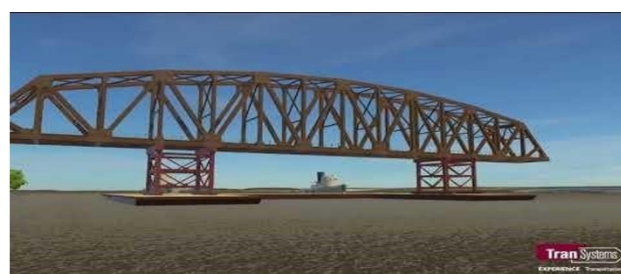
Figure 1 - Float-in Concept Developed by EOR

The construction team reviewed several replacement options during the bid phase. The first option considered was building the truss on a fixed platform or barges at elevation similar to Figure 1. This would keep hoisting to a minimum but ultimately had too many issues. The truss would have needed to be built 80' in the air at

normal low water. That lead to stability concerns on the barges and access issues during construction. With the strong current, the team was also concerned about securing the barges in the current to land the bridge precisely on the pier cap.

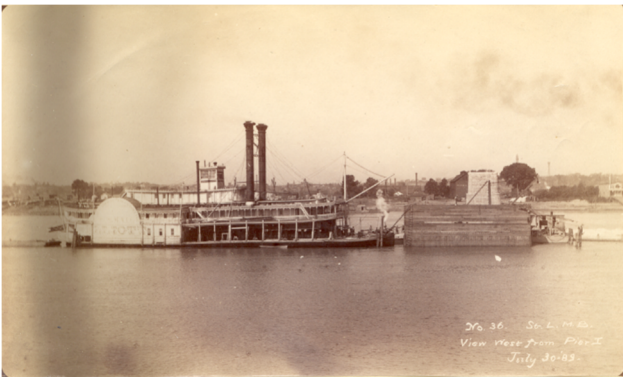
Figure 3 - Original Bridge Caisson Construction

The bridge is founded on a timber caisson that was constructed on land, floated out to the pier location in the river and ballasted down to the riverbed as shown in Figure 3.

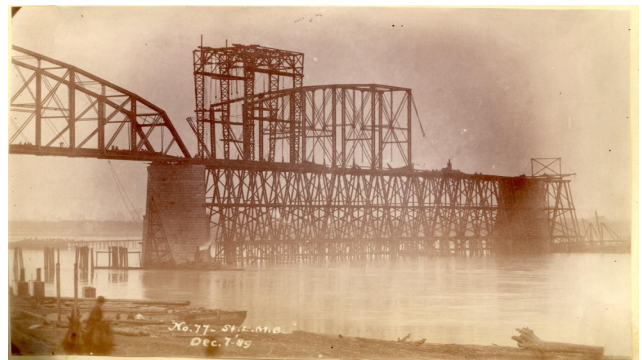
Figure 4 - Original Bridge Main Truss Span Construction

The superstructure, shown under construction in Figure 4, is a 517' 4-million-pound steel truss. During construction, a timber trestle was installed that blocked parts of the river as shoring. The timber piles survived under the riverbed for 130 years and ended up being major obstructions for the cofferdam work on the new bridge.

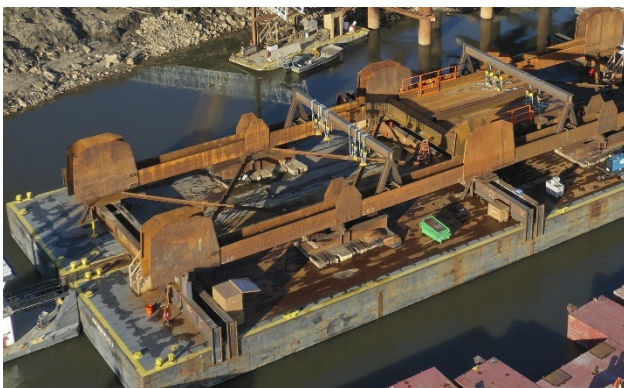
Figure 10 - Barge Grillage used for Truss Erection

The truss was constructed on 4, 35x195x10.5' barges that were paired together using twin W40x503 spine beams. Reference Figure 10. In order to get the load from the weight of the 9-million-pound span in to the barges, the W40x503 beams were welded to the sides of the barge instead of the top to more efficiently deliver the load in to the barge's internal framing. This also required the construction team to send the barges to a local shipyard to strengthen the barges prior to loading.

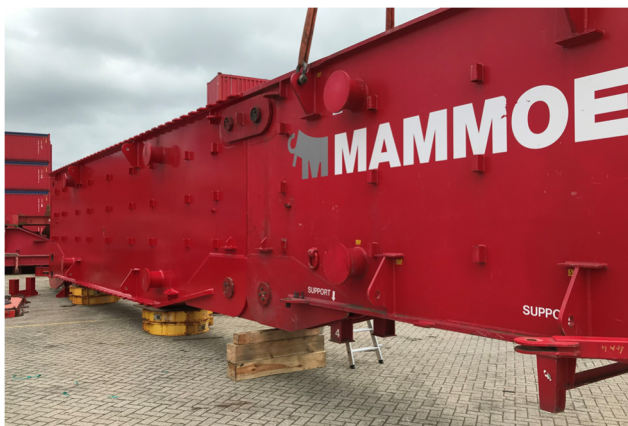
Figure 12 - New Larger Profile P55 on left connected to original P55 profile.

1. One gantry system was- built using an existing Mammoet beam system called the P55 beams. These beams were made from grade 100 plate. The original beams, designed in the early 2010's, were made to fit in standard 40' shipping containers with custom end caps to allow the beams to be made into a 40' container. To achieve the beam length and strengths requirements for this project, Mammoet designed new taller beams sections to be spliced together with the original 2010 beam. The new beams sections were located at midspan to handle the maximum bending forces. These new taller sections were also containerized, but were the max height of a container. See Figure 12 for a profile.

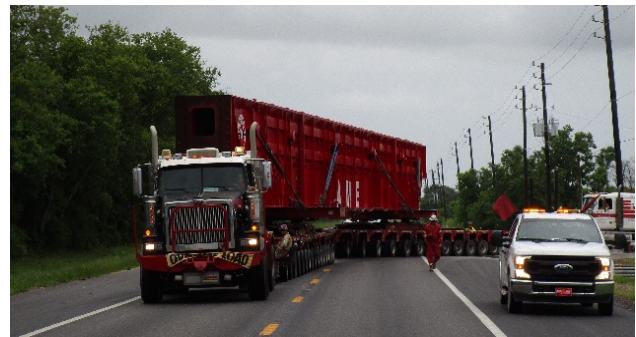
Figure 13 - PDV beams transported using SMPTs

1. The PDV beams. With a total length of 154'-2", the beams were reinforced and bolted together at the Mammoet yard in Rosharon, Texas. The beams were then loaded onto dolly load 16-line GH and truck pulled from Mammoet yard in Rosharon, Texas to Freeport, Texas to be loaded onto awaiting deck barges. See Figure 13 & Figure 14.

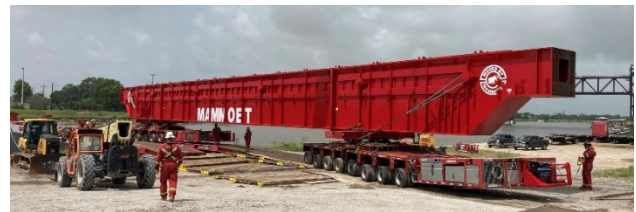
Figure 14 - PDV beam being loaded onto deck barge

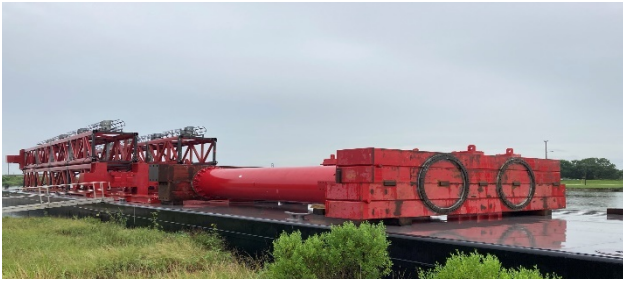
Figure 15 - Completed components loaded onto deck barge for transport to St. Louis

2. Two additional items that were pre-assembled for shipment were the MJS tower and the pipe columns. The MJS towers were fully assembled in the Mammoet yard and trucked down to the barging location. The pipe columns had to be shipped in pieces down to freeport and assembled on site since these were too wide to ship economically. This can be seen in Figure 15.

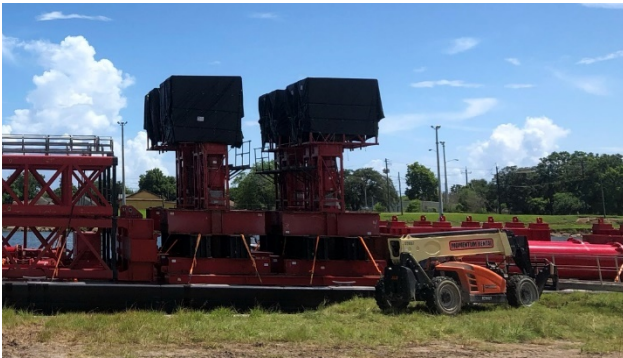
Figure 16 - Strandjack assembly with protective tarps

3. The last major component preassembled is the strandjack assembly seen below in Figure 16. The strandjacks had this individual wire put into the jacks and the re-coilers. This way all the work of stabbing the wire into the jacks could be done prior to the jacks being shipped. Once down at the Freeport loading site, the skid beams and support beams were flown onto the barge, and then the strandjacks with the re-coilers were flown onto the system to make it complete.

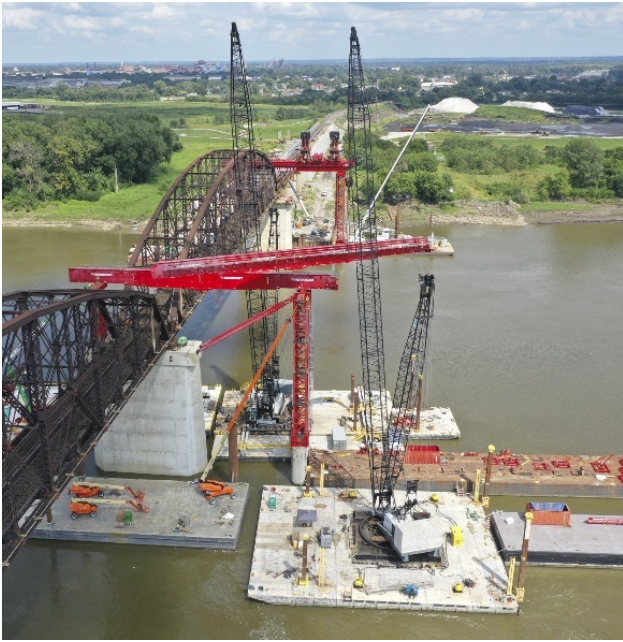
Figure 17 - Installation of Mammoet Gantry Beams. Downstream Falsework Temporarily Braced

1. Erection of the taller downstream tower. During truss installation, the stability of the downstream tower was provided by the pipe brace secured to the gantry beam and the existing pier. Prior to erecting the overhead gantry beams, the stabilizing pipe brace was installed to provide the necessary adjustment / stability in the system to allow the beams to stay within dimensional tolerances. This brace can be seen Figure 17.

2. Installation of the 350-kip gantry beams 100-ft in the air. Due to reach limitations with the ringer cranes, the 350-kip gantry beams had to be rigged and set back down multiple times so the ringers could be repositioned. This was achieved by using two legs of the J&R 700ton Gantry system. The two legs were clipped and chained down to the top of the pier. Once the beams were set down, it allowed the ringer crane to be repositioned to finish the installation of the gantry beams. One advantage to using the J&R gantry system is it allowed the gantry beams to be set down and leveled with the hydraulics if needed prior to shimming at the final supports.

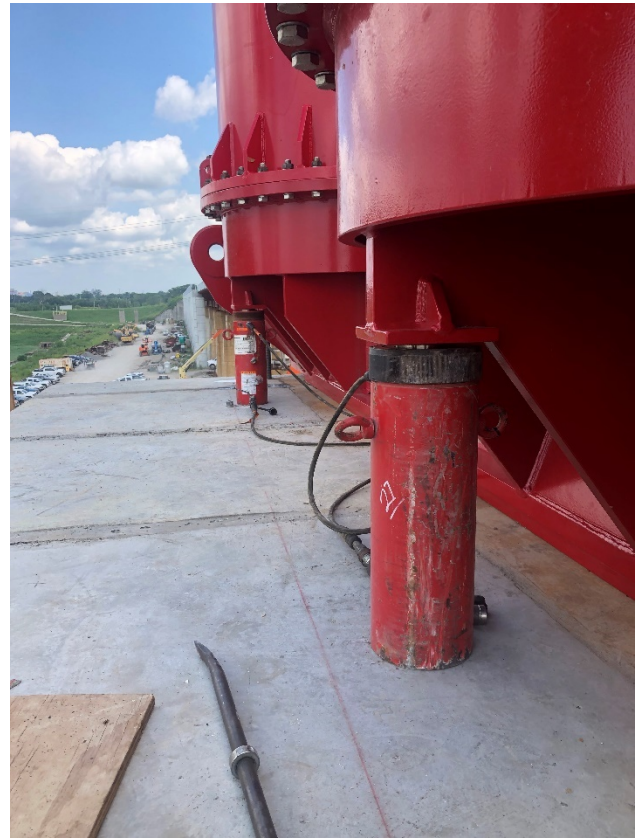
Figure 18 - Jacks used to help level upstream pier side columns.

3. As with the downstream tower, the upstream pipe supports could also be adjusted using hydraulic jacks under specially designed wings into the pipe column bases. See Figure 18. Providing adjustability in the upstream and downstream towers helped ensure the system behaved as predicted in the computer simulation modules.

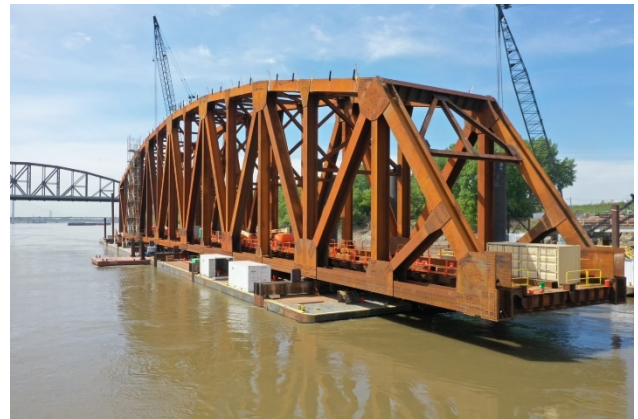
Figure 20 - New Truss Completed on Assembly / Float-in Barges – 2.5-ft of Freeboard Remaining

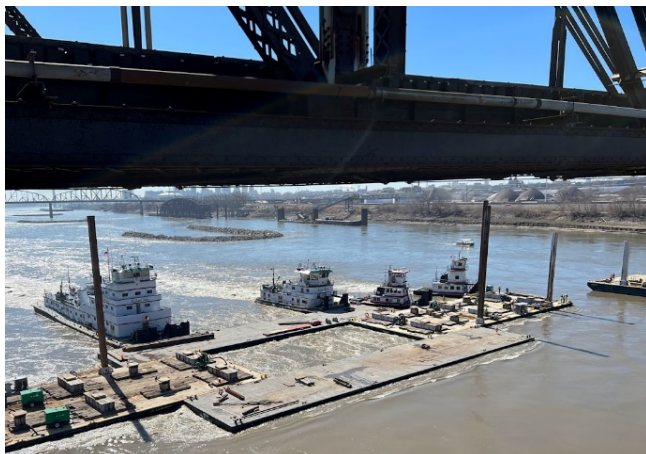
Figure 22 - Float-Out Barges Ballasted Down for Test Push with Tugboats

The Contractor wanted to verify that the 14,000 horsepower was sufficient for handling the new truss before removing the existing. A test push was performed with the float-out barges ballasted down to similar free boards, see Figure 22.
